# Rock Mass Characterization for Assessment of Safe Cut Slope and Rock Bearing Capacity at Gondang Dam Site, Karanganyar, Indonesia

ABSTRACT. This paper presents results of surface rock mass characterization for assessment of safe cut slopes and allowable bearing capacity of foundation rocks at the construction area of Gondang Dam. The rock mass characterization involved determination of intact rock engineering properties and rock mass quality based on the Geological Strength Index. The rock mass characterization results showed that the research area consisted of moderately to highly weathered and very weak to weak andesite breccia and andesite tuff breccia. The andesite breccia had very poor to fair rock mass quality, while the andesite tuff breccia had poor to fair rock mass quality. The research area was divided into three zones of safe cut slope and allowable bearing capacity. Landslides occurred at natural slopes having poor to very poor rock mass quality and inclinations greater than the determined safe cut slopes. The foundation rock of the embankment dam had fair rock mass quality and 135–280 T/m² allowable bearing capacity.

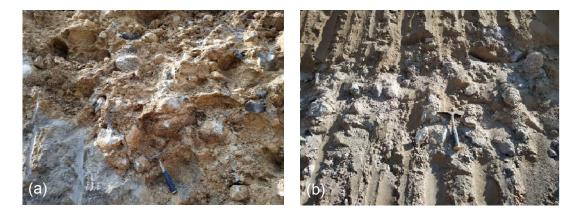
Results of the site investigation indicated that the research area consisted of two rock units, namely andesite breccia and andesite tuffbreccia (Figure 2). Referring to the regional geological map produced by Sampurno and Samodra (1997), the two rock units were likely member of Lawu Volcanic (Qvl). Figure 3 and 4 show typical outcrops of the two rock units. The andesite brecciatypically consisted of 50 % of 2 cm to 1 m-sized andesite fragments, 45 % of medium to coarse sand-sized matrix, and 5 % of tuff. The andesite tuff breccia typically consisted of 30 % of 1 to 20 cm-sized andesite fragments, 30 % of fine sand-sized matrix, and 40 % of tuff.

Figure 3: Typical rock outcropsin the research area: (a) andesite breccia; (b) andesite tuff breccia.

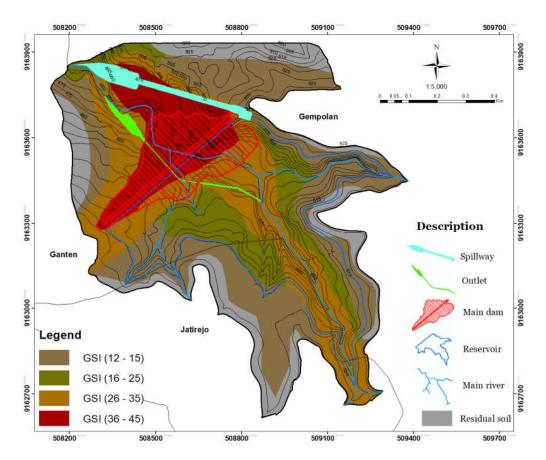
The rock masses in the research area had moderately to completely weathering degree with GSI values ranged from 10 to 45 (Figure 4). Residual soils were also developed particularly on the upper part of the andesite tuff breccia. The andesite breccia had very poor to fair rock mass quality, while the andesite tuff breccia had poor to fair rock mass quality. Table 1 presents the engineering characteristics of rock masses for each GSI range. Following classification proposed by ISRM (1981), the intact rocks of andesite breccia and andesite tuff breccia were categorized as very weak to weak rocks.

Figure 4: GSI zones in the research area.

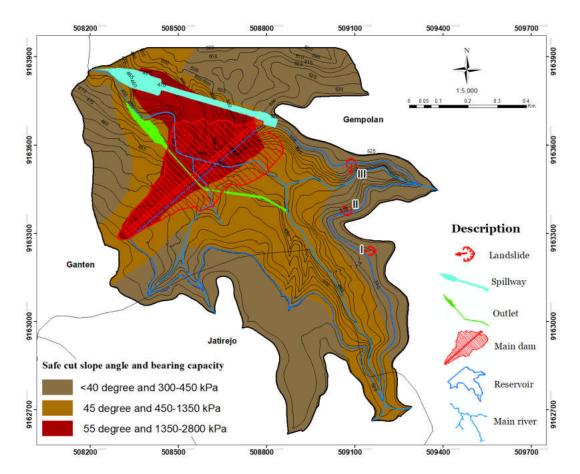
i.e., very poor rock mass quality (RMR 17–20) had less than 40° safe cut slope angle and bearing capacity ranged from 30 to 45 T/m²; poor rock mass quality (RMR 21–40) had a maximum of 45° safe cut slope angle and bearing capacity ranged from 45 to 135 T/m²; and fair rock mass quality (RMR 41–50) had a maximum of 55° safe cut slope angle and bearing capacity ranged from 135 to 280 T/m². The criteria for safe cut slope and allowable bearing capacity of rock masses in the research area are summarized in Table 2, while the zones of safe cut slope and allowable bearing capacity of rock masses are shown in Figure 6.

Figure 5: Zones of safe cut slope and allowable bearing capacity of rocks in the research area.

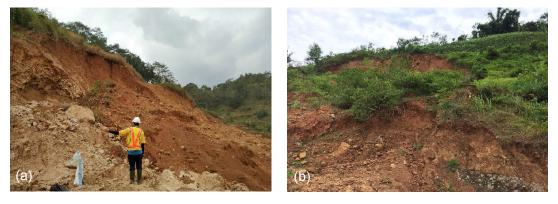
Natural slopes at the right (east) side of the dam reservoir had poor to very poor rock mass quality and relatively steep inclinations ranged from 35° to 55° (Figure 4). Two of three landslides identified during the field are shown in Figure 6, where the locations of those landslides are shown in Figure 5. The landslides likely occurred due to the natural slopes having greater than 45° angle, while they should have a 40° safe cut slope determined from the rock mass quality analysis. In term of bearing capacity, the embankment dam was designed to be constructed on the fair quality of foundation rock having allowable bearing pressure ranged from 135 to 280 T/m².

Figure 6: Typical landslides of the natural reservoir slopes: (a) Landslide I and (b) Landslide II. Locations of these landslides are shown in Figure 5.
