# EVALUATION OF ROCKFALL OCCURRENCE IN PADANG–BUKITINGGI ROAD, WEST SUMATRA, INDONESIA

Wahyu Wilopo\*, Dwikorita Karnawati, Salahuddin Hussein, and Ignatius Sudarno

*Department of Geological Engineering, Gadjah Mada University, Yogyakarta, Indonesia*

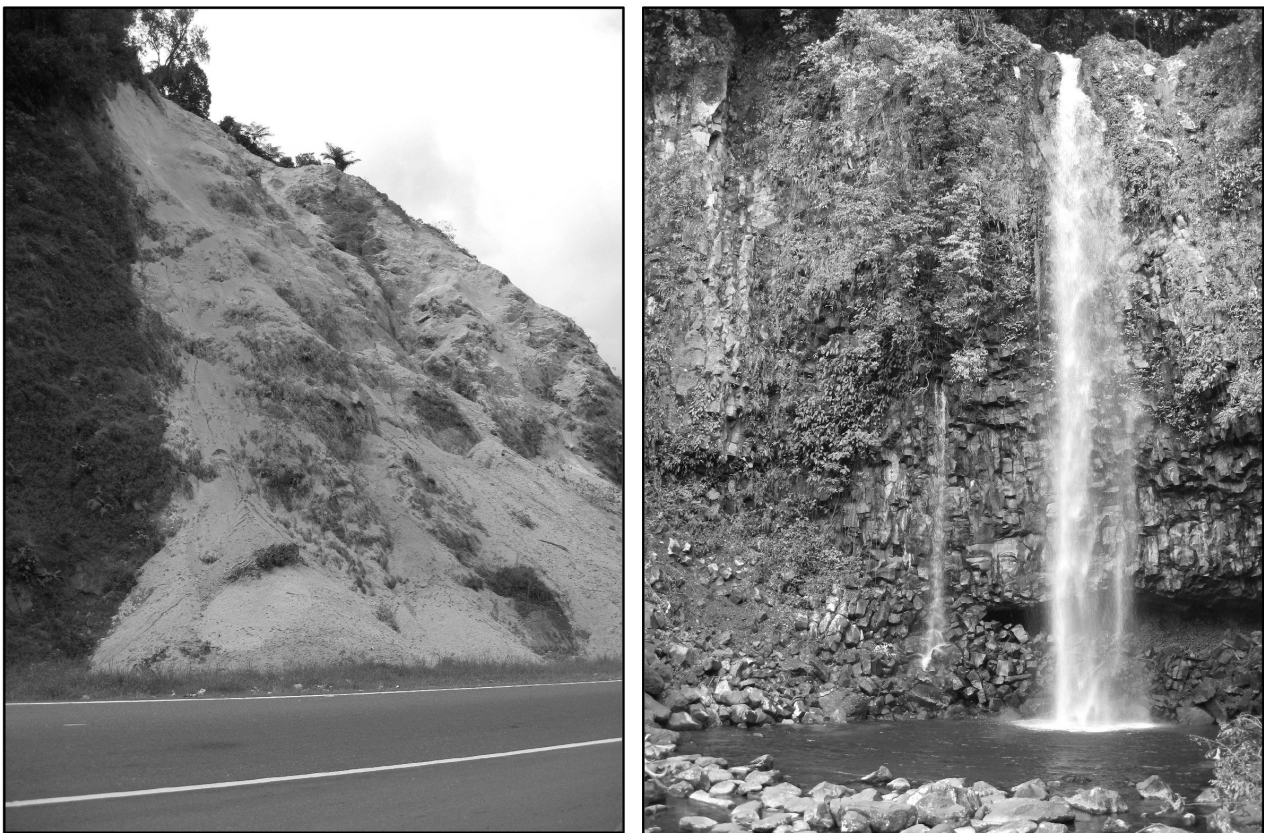
The geological formations encountered in the area consist of pumice tuff (Katowo, et al., 1996). The rock slope overhanging the road from Padang to Bukittinggi consists of andesite. A section of this road cuts the great Sumateran fault, therefore this area is very complex in term of geological structures. Two major fault zones with NE-SW and NW-SE strike intersect the formation, forming the valley as shown in Figure 1. The pumice tuff and andesite rock mass is strongly fractured and weathered, intersected by numerous major vertical and horizontal fractures which have a parallel strike to the fault structures that forms the rock face (Figures 2a and 2b). The spacing of the discontinuities is relatively small (less than 1 m); however, there

Figure 2: (a) Slope of weathered pumice tuff; (b) Fractured andesite in Anai Waterfall

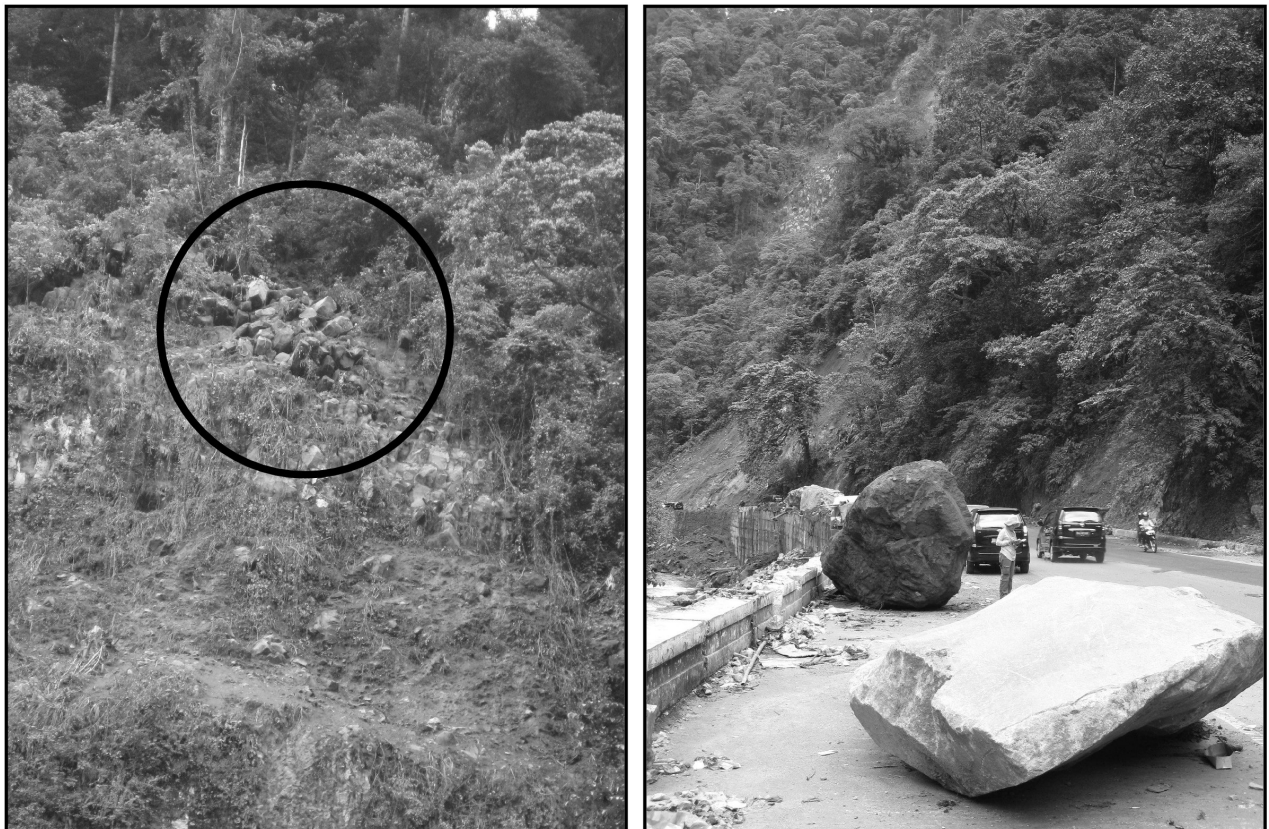
are also big boulders in the top of slope. In places, mainly due to stress relief, the rockmass is very blocky and the size of the rock blocks is smaller especially on the upper part and the crest of the slope where the wall of road is situated.

Figure 3: (a) Andesitic materials that are still hanging in the top of slope; (b). A big andesite boulder from the rockfall

associated drainage, construction of buttresses in overhanging areas and removal of unstable boulders are necessary, however can be inapplicable or very difficult to construct in high rock cliffs. The installation of a steel protection net or sprayed concrete is not acceptable due to the wide area. As discussed earlier, the scale of some potential failures is such that no stabilization measures can minimize or withdraw the risk of a potential rockfall after their application. Even high-energy rock fall barriers would prove insufficient in the case that the rock blocks shown in Figure 3 are detached from the cliff. A possible support solution, in this case, would be to install tensioned wire-rope cables around the rock boulders to resist their movement and to grout any open discontinuities with appropriate drainage holes.

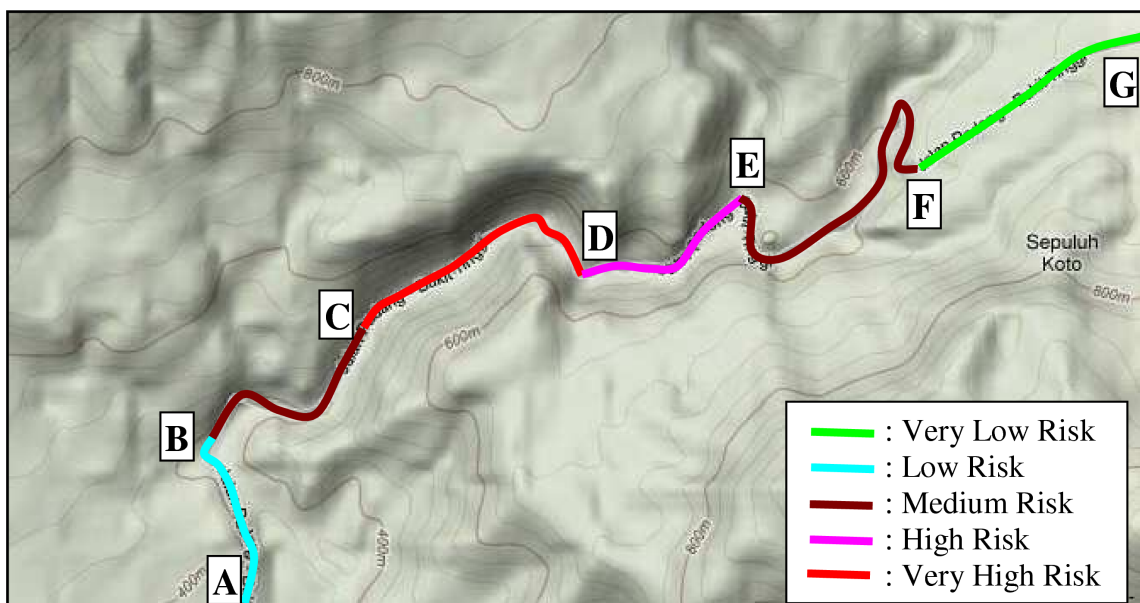
The stability conditions of the rock slope are mainly controlled by the following factors: a) due to spacing, large blocks are prone to fall, b) lack of persistency of the discontinuity planes, which results in instabilities only in specific parts of the slope, c) lack of weak zones, which would result in large shear failures, d) the rock face is in a state of relaxation due to the high inclination of the slope (Marinose, et al, 2009). The rock slope stability analyses were based on the prevailing mode of instability of each potential rock failure. The principal failure type is rockfall due to a sort of toppling and bouncing (Figure 3). The rock blocks were delineated and their geometry and mass was determined. Due to the inaccessible nature of the slope, the assessment of the above characteristics was based on the topographic map of the rock cliff. These characteristics were grouped and specific sections (A to G) were formed for separate analysis (Figure 4). The surveying and mapping of the high rock cliff were based on a new geodetic methodology and using the topographical map from secondary data. The height of the source of fallen-potential blocks is at the minimum of 70 meters above the road, while in some places it reaches 280 meters. The size of the unstable materials which are more probable to fall is only between  $0.5 \text{ m}^3$  to about  $5 \text{ m}^3$  (Fig. 4a), except in the area between Sections C - D (Figure 4a) where the size can go up to  $20 \text{ m}^3$ . In the area shown in Figure 4, the potentially unstable blocks have very large dimensions.

Figure 4: Risk zonation of rock slope based on rockfall rating system

application is a risk zonation of the cliff against rockfall occurrence, presented on the risk map shown in Fig.4. The map depicts the areas of having a high and very high risk due to either increased number of existing unstable boulders or restricted area for their catchments or combination of both and the high of cliff. The risk categories are presented in Table 2. The slope foot area between sections C to D presents very high risk due to the numerous unstable boulders on the high cliff with the size more than 5 m<sup>3</sup>, therefore the installation of barriers is not possible. The area between sections D to E has high risk, due to lower cliff than C- D, which offers possible conditions for installation of barriers. The area between sections B to C and E-F does not have many boulders and stills many vegetation with medium slope and low cliff.

Category	Rating	Risk	Protection Measures	Section
I	< 20	Very low	Not necessary	F – G
II	20 – 40	Low	Occasionally necessary	A – B
III	40 – 60	Medium	In limited extend	B – C; E – F
IV	60 – 80	High	Combination of active and passive measures is necessary	D – E
V	80 – 100	Very high	Critical state of stability, combination of active and passive measures is absolutely necessary	C - D
