Performance Evaluation on Low-Crest Breakwater at North Coast of Java Island

Parlindungan Sudrajat Simanjuntak

Board of Kalimantan I River Basin, Ministry of Public Works, Pontianak, INDONESIA

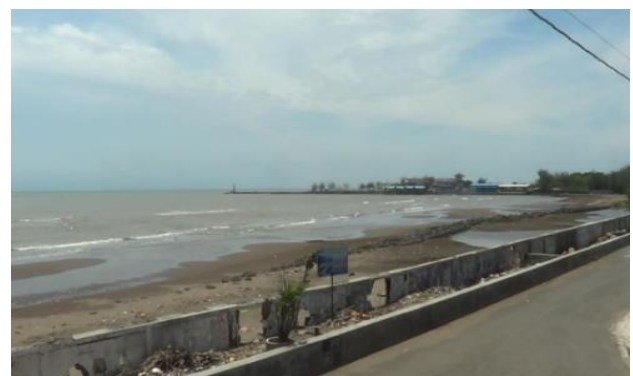
Figure 8. Conditions of Pekalongan Beach in 2017.

Before low-crest breakwater was installed, the beach suffered from erosion and coastal flood that threaten settlement condition around the coast (HuMa, 2006); even though construction of coastal safety has been conducted, such as with seawall, groin, and masonry. After the coastal safety construction used the low-crest breakwater structure, condition of the beach has got several changes, such as beach growth by sedimentation presence in the location where the structure was installed. The view of Pekalongan Beach in 2017 is shown in Figure 8.

Erosion management in Pekalongan City Beach by using low-crest breakwater structure generally showed a positive result, by beach growth of 15 to 20 meters; however, Slamaran Tourism Beach generally has not shown a positive result; it's evident from the yet absence of new beach development in form of beach growth. Further evaluation of this condition should be conducted because other locations on Pekalongan coast already have new beach growth.

This structure was located at 15 to 20 meters distance from the beach, therefore there was no significant damage made by beach visitors. On low-crest breakwater structure with geobag mounted along the beach, repairment and monitoring are necessary, because several damages that occurred, such as sand loss, that could create further destruction. Low-crest breakwater structure with geotube was located on location far from visitors and tourists, but monitoring needs to be conducted on the damages.

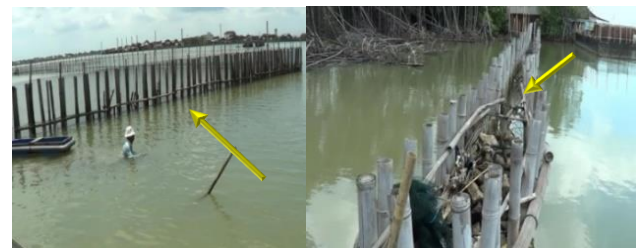
(a) Hybrid Low-crest Breakwater In Front of the Settlement and Mangrove Protection

Hybrid Low-crest Breakwater as shown in Figure 11 was installed on three positions, which are in front of the settlement, at side of the settlement, and at the mangrove plant protection. The observation on Hybrid Low-crest Breakwater showed that the best performance was the ones at the side of the settlement, in which it holds the coastal flood wave that goes

directly to the settlement. There was no material filling on the Hybrid Low-crest Breakwater that was installed in front of the settlement, therefore it is not working; while several points of the installation on the mangrove plant protection were still not filled, therefore the protection does not run well and the mangroves are suffered from damages.

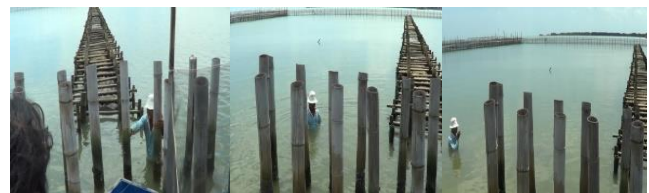
(b) Geobag Low-crest Breakwater with Bamboo Poles

only relatively small damages occurred, in the form of declining position of the bamboo pole, which needs monitoring and repairment. Another repairment that could be conducted is cleaning the shells that are attached, so as not to cause further damage to the structure.

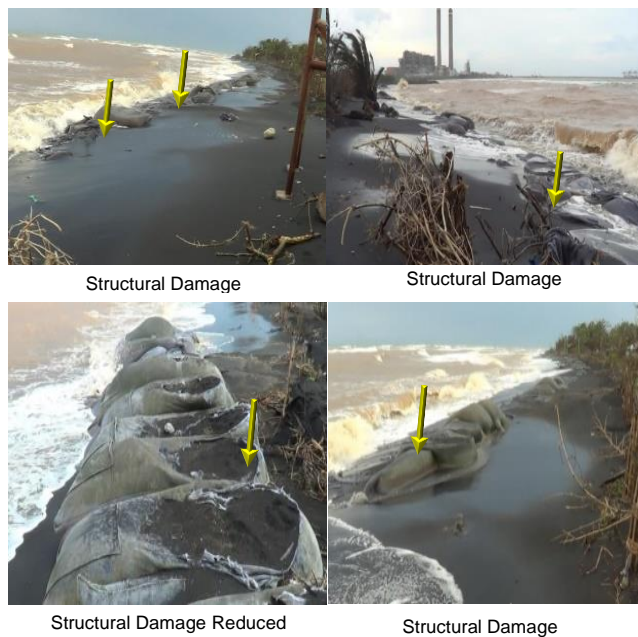
Figure 14. Structural damage of the low-crest breakwater structure on Jepara Regency

Based on the observation, low-crest breakwater installation on Bayuran Beach did not show the expected result, because of damages that occurred on the material and structure of the low-crest breakwater. The condition of the low-crest breakwater structural damage was shown in Figure 14, in which from the structure up to the foundation of the coastal safety structure suffered from damage.

Erosion management with low-crest breakwater structure along the shoreline of Bayuran Beach in Jepara Regency showed structural damages that were shown in almost all of the low-crest breakwater installation points. This then caused the expected result from the installation did not generate.

Damages on the low-crest breakwater structure on Jepara Regency could occur because of the low-crest breakwater material that is not in accordance with the

condition on the field, in which a type of shell material that exists on the beach location could damage the low-crest breakwater material. Another cause that could contribute to the damage is the placement of fishing boats on the location of the coastal safety structure. This is because the type of low-crest breakwater material, which was geotextile, is not a material that strong enough to resist the friction from the boats.

- c) Geotextile material damages mostly when in direct contact with human. Other than that, a location in which boat or offshore water activities are present would greatly damage the structure material. Therefore, protection installation is needed, such as fence or warning sign to avoid possible destruction.
