THESIS SUMMARY

SUITABILITY ANALYSIS OF OFFICE BUILDING DESIGN AGAINST MAINTENANCE COST

(Case Study: Institution of Serayu Opak River Basin Organization, Water Resources Field
and Water Resources Management Center in Yogyakarta Special Region)

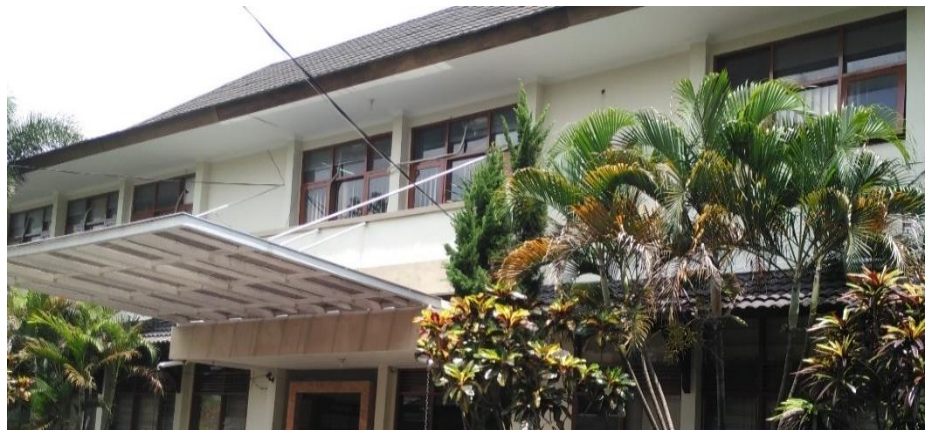
Buildings that became the object of research using a lot of clear glass as a cover of the building so that the rooms are exposed to the sun's heat during the afternoon, so the room becomes hot and glare. The hot and glare room is not suitable with the comfort requirements of the building contained in Government Regulation No. 36/2005 on the Implementation of Law Number 28 Year 2002 regarding Building. Image of the exposed part of the building can be seen in Figure 4.1.

Figure 4.1 Side of the Serayu Opak River Basin Organization building

Glass used in the building is clear glass 3 mm. Clear glass has the nature of continuing 90% of visible waves and 85% of the sun's radiation into the room thus making the room become glare and room temperature increases. To reduce the heat and the glare in the room, the best solution that can be done is to install window film. In order not to reduce the aesthetics should use a clear window film with a large TSER value on building glass. *Total Solar Energy Rejection* (TSER) is the total capacity of film glass to resist VLT, ultraviolet and infrared rays

- a. Renovate the roof and side of the building by installing a heat insulator on the roof and coated glass with clear film glass.

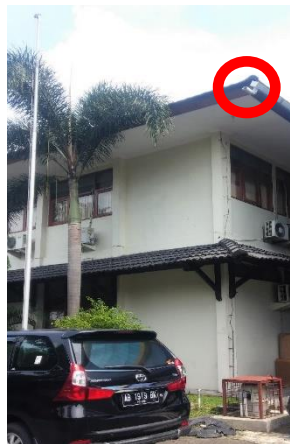
Figure 4.2 Rainwater gutters without vertical pipes at Serayu Opak River Basin Organization building

In Figure 4.2 we can see the design of less suitable gutters because the outlet pipe (funnel) is located at an altitude of ± 7 m from the soil surface so that the rain flow from the roof will fall inappropriately in the rain drain. Should be on the gutters mounted vertical pipe to approach the sewer so that rain water from the roof can be entirely wasted into the sewer. Should be on the gutters mounted vertical pipe to approach the sewer so that the rain water from the roof can be entirely wasted into the sewer and then flowed to the city drainage channel.

- 2) The gutter design of the Serayu Opak River Basin Organization (SORBO) building is less suitable because there is no vertical pipe to drain rainwater from the roof to the sewer.

- b. Replace / redesign the gutter by adding a vertical pipe to the outlet pipe (funnel) to allow rain water to enter fully into the drain.
- c. Equip toilets with facilities in accordance with Indonesian Public Toilet Standards.
- d. Increase access for PwDs.
- e. Install the alarm for emergency situations so that the evacuation process can be done earlier and faster.
- f. Make clear signs and parking limits.

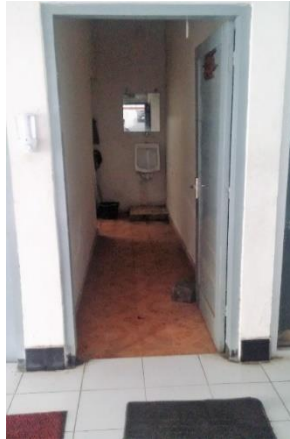
The location of the urinal at the end of the toilet and facing directly into the corridor is less unsightly, especially when there are employees who use it to urinate.

Figure 4.3 Location of urinal in PJSA and Water Resources Field (WRF) building facing corridor

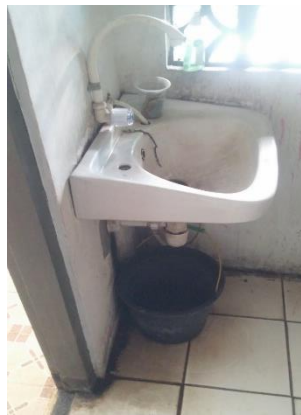
The sink position in Water Resource Management Centre (WRMC) building is not in accordance with Indonesian Public Toilet Standards because it is installed in the corner and too close to the wall making it difficult for users to wash their hands and or faces. To be more clear, the position of the sink can be seen in Figure 4.4.

Figure 4.4 The location of the sink in the Water Resources Management Centre (WRMC) building

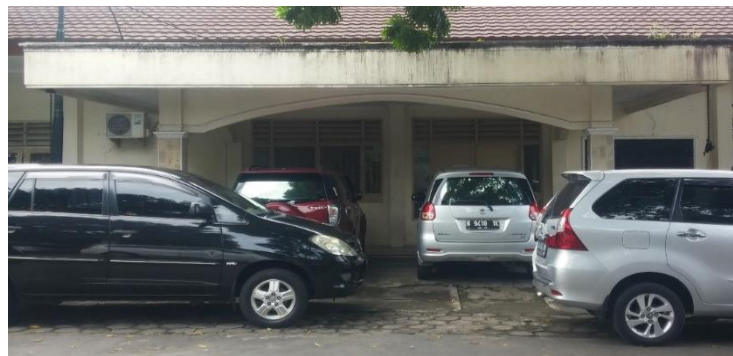
- 3) There is a parking lot of vehicles blocking access to the entrance.
This is due to the absence of signs, parking borders and information boards so that workers park vehicles freely.

Figure 4.7 Access to entrance of PKSDA building blocked by vehicle

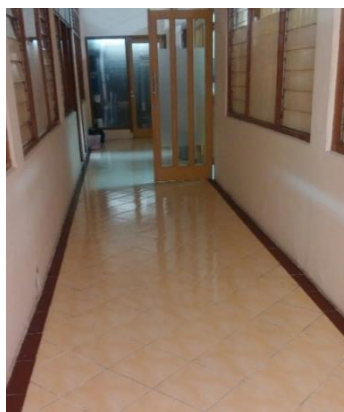
- 1) The corridor design is less wide
The corridor of Serayu Opak River Basin Organization (SORBO) building area has only 1.7 m width. Not in accordance with the Regulation of the Minister of Public Works No. 45/PRT/M/2007 Year 2007 on Technical Guidelines Development of the State House, which requires a minimum width of 1.8 m net corridor.

Figure 4.8 The corridor of Serayu Opak River Basin Organization (SORBO) building

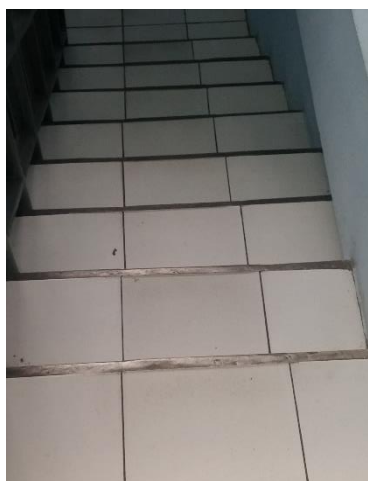
Residential building / building consisting of 2 floors or more, the size of the stairs used has a minimum width of 1.25 m. However, the staircase in the Water Resources Management Office building is only 85 cm wide.

Figure 4.9 Stair in Water Resources Management Building
