THESIS SUMMARY

SUITABILITY ANALYSIS OF OFFICE BUILDING DESIGN AGAINST MAINTENANCE COST

(Case Study: Institution of Serayu Opak River Basin Organization, Water Resources Field
and Water Resources Management Center in Yogyakarta Special Region)

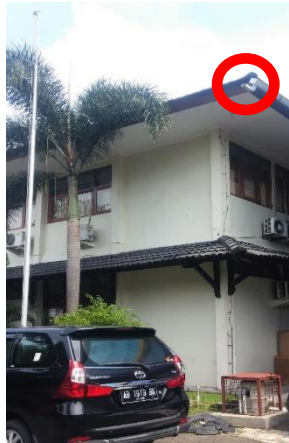
Figure 4.2 Rainwater gutters without vertical pipes at Serayu Opak River Basin Organization building

In Figure 4.2 we can see the design of less suitable gutters because the outlet pipe (funnel) is located at an altitude of ± 7 m from the soil surface so that the rain flow from the roof will fall inappropriately in the rain drain. Should be on the gutters mounted vertical pipe to approach the sewer so that rain water from the roof can be entirely wasted into the sewer. Should be on the gutters mounted vertical pipe to approach the sewer so that the rain water from the roof can be entirely wasted into the sewer and then flowed to the city drainage channel.

- 2) The gutter design of the Serayu Opak River Basin Organization (SORBO) building is less suitable because there is no vertical pipe to drain rainwater from the roof to the sewer.

- b. Replace / redesign the gutter by adding a vertical pipe to the outlet pipe (funnel) to allow rain water to enter fully into the drain.
- c. Equip toilets with facilities in accordance with Indonesian Public Toilet Standards.
- d. Increase access for PwDs.
- e. Install the alarm for emergency situations so that the evacuation process can be done earlier and faster.
- f. Make clear signs and parking limits.

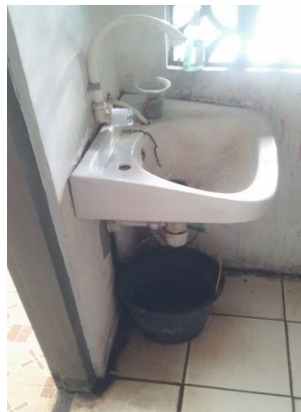
The sink position in Water Resource Management Centre (WRMC) building is not in accordance with Indonesian Public Toilet Standards because it is installed in the corner and too close to the wall making it difficult for users to wash their hands and or faces. To be more clear, the position of the sink can be seen in Figure 4.4.

Figure 4.4 The location of the sink in the Water Resources Management Centre (WRMC) building

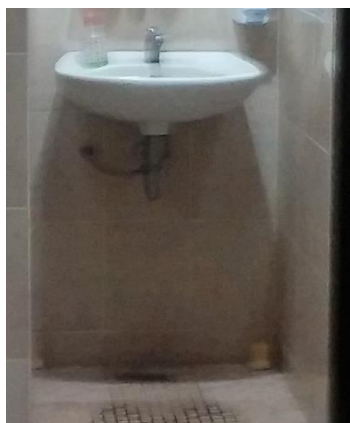
The width of the sink room in the toilet room of the Serayu Opak River Basin Organization which is only 75 cm in size is not suitable with the recommended size in Indonesian Standard Public Toilet by 90 cm. The width of the sink room in the toilet of Serayu Opak River Basin Organization can be seen in Figure 4.5.

Figure 4.5 The sink room in the toilet of the Serayu Opak River Basin Organization building

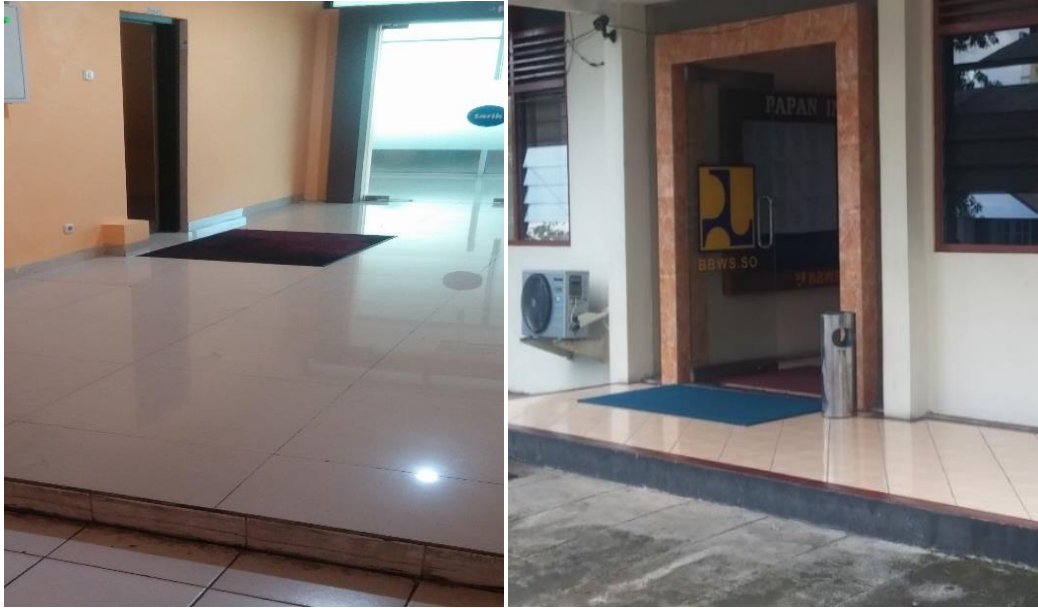
- 1) The absence of guiding block and Braille facilities around the building
Can reduce accessibility for the visually impaired.
- 2) There is a step on the access to the entrance and toilets.
This makes it difficult for wheelchair users to enter the building without assistance. It should be at the entrance of the building made ram so that wheelchair users can enter the building with ease.

Figure 4.6 The steps at the entrance of Serayu Opak River Basin Organization toilet and building
