Coating in Primary Reformer's Radiant Section

Baskara Aji Nugraha*

PT Kaltim Parna Industri, Kaltim Industrial Estate
Bontang, Kalimantan Timur, 75314
Bontang KPI, Jl. Pupuk Raya Km.2 Bontang

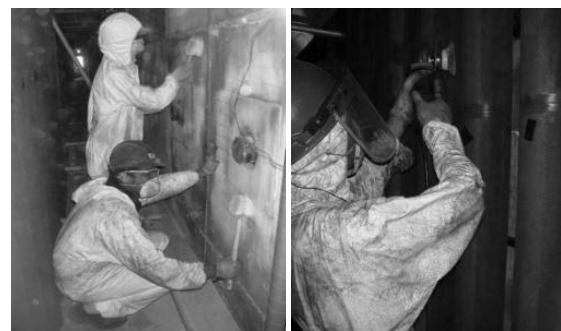
Figure 3. Brushing reformer tube and re-fractory surface hand brushing

1. Coating material preparation. This step was conducted by our vendor.
2. Scaffolding installation. We hired a subcontractor, local based, to install scaffolding inside radiant section.
3. Brushing reformer tube and surface preparation. In order to eliminate dust particles attached at tube and radiant wall, we brushed them so the result of coating would be satisfied.

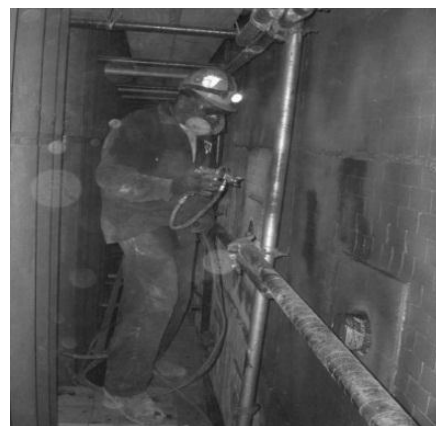
Figure 4. Application of coating

A mixture of furnascote in water (25 kg of furnascote in 3.2 Liters water) was applied using a paintbrush. Required quantity was about 2 – 3 kg/m² in order to achieve a thickness of 1 – 2 mm (arbitrary). It had a good adhesion to the

4. Coating application. The mixture of furnacecote was spreaded all over radiant section wall.

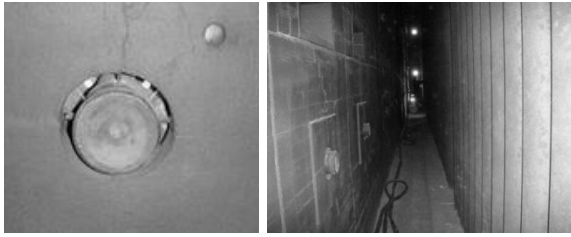
1. Visually, the coating material strongly attached to the castable surface. Only minor

deterioration occurred. Further investigation showed that the coating was thicker than the others. Therefore, it was concluded that excessive thickness was not preferable.

Figure 5. After coating (cold condition)

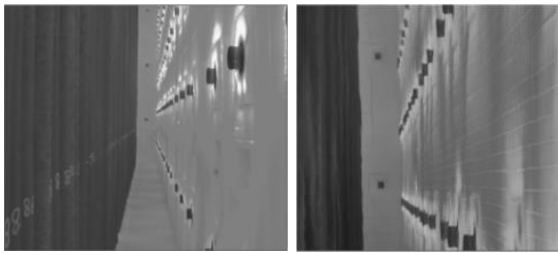
- Coated surface was smoother than non-coated surface, which is in line with observation during operation. This surface was shinier, which indicated better reflections. Inspection through peephole indicated that radiant wall illuminated brighter than before. It could be said that the radiation heat transfer increased. (Beacon, 2009)

Figure 6. Radiant wall in hot condition before coating (left) and after coating (right).

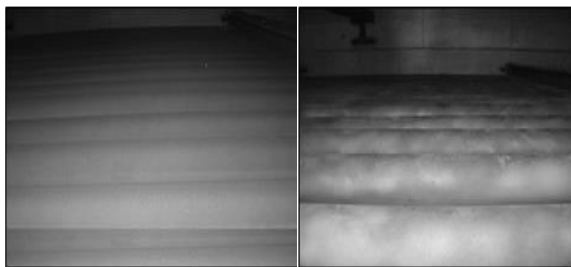
During process turn around, there was opportunity to inspect the convection section and it was found that exchanger's coils were severely fouled by red-colored material. Physical appearance indicated that the material was similar to the refractory (radiant wall), which was further confirmed by laboratory analysis.

Red fouling can be removed even from the hardest positions inside the tube bank.

Figure 7. Coil exchangers condition before cleaning (left) and after cleaning (right).

Before coating radiant section was conducted, we had to clean convection section in order to eliminate fouling film attached on coil exchangers. Cleaning was carried out by sandblasting using garnet sand since refractory material is sensitive to water (wet cleaning method). Garnet 20/40 mesh (425 – 850 microns)

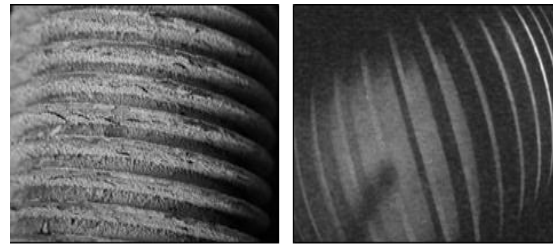
Figure 8. Finned coil exchangers condition before cleaning (left) and after cleaning (right).
