Vulnerability Assessment of Fallen Trees Along Arterial Road of Bukit Soeharto Grand Forest Park Using Google Street View

Ali Suhardiman^{*}, Frans Milan¹, Yosep Ruslim¹, Ariyanto¹, & Hari Siswanto¹

¹Forestry Study Program Undergraduate Program, Faculty of Forestry, Mulawarman University, Samarinda 75123, Indonesia

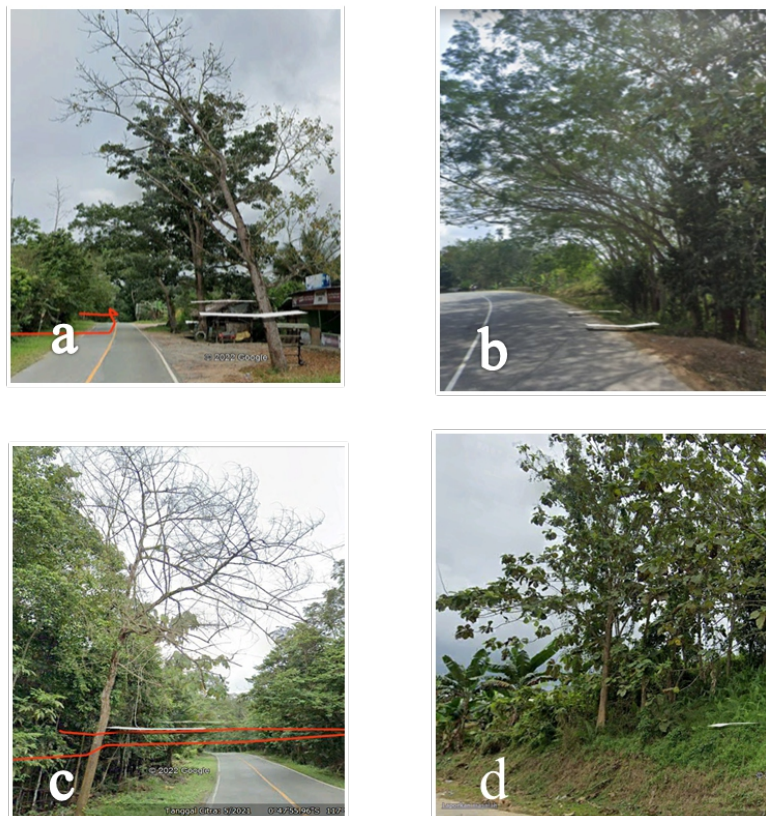
- I. Trees with sloping trunks or leaning towards the body of the road.
- II. Trees whose canopy proportions were predominantly pointing to the road.
- III. Trees without leaves, and possessed dry trunks.
- IV. Trees in the area of slopes or cliffs whose existence was higher than the body of the road.

Figure 2. The criteria for fallen trees seen from GSV: (a) trees whose trunks are sloping or leaning towards the road body; (b) trees whose canopy proportions point to the road body; (c) dry/dead trees; (d) trees located in slope or cliff areas whose presence is higher than the body of the road.

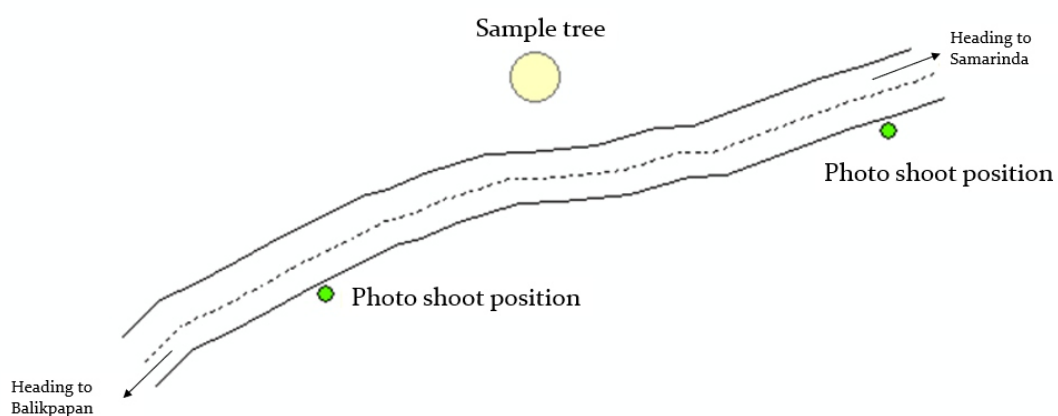
Figure 3. Photo-taking positions on samples of fallen trees observed in the field.
