# Geotechnical Investigation and Numerical Analysis of Rockfall in South Coast of Gunung Kidul Regency

Odhi Attabik Illiyin

Fikri Faris

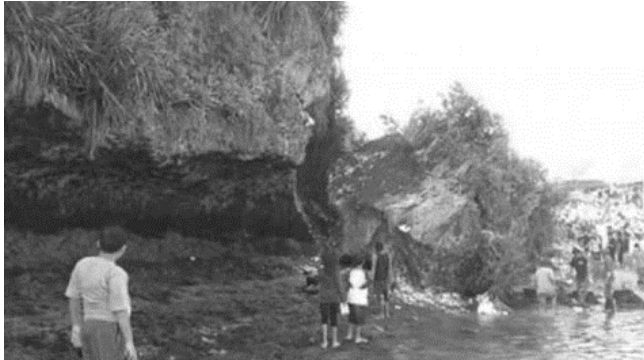
On June 17<sup>th</sup>, 2015, rockfall from cliff in Sadranan Beach fell on a number of tourists as seen in Figure 1. The incident occurred at 15:00 Indonesia Western Time (UTC+7) claimed four casualties and injured two people (Yuwono, 2015b). Founded with the background of the incident, MEMR had conducted investigations on the area around Sadranan Beach. The investigations concluded that the cliffs on the beach are generally dangerous, and it is feared that similar disaster could happen again in the future (Yuwono, 2015a).

Figure 1. The rockfall incident on 17th of June, 2015 (Kusuma, 2015)

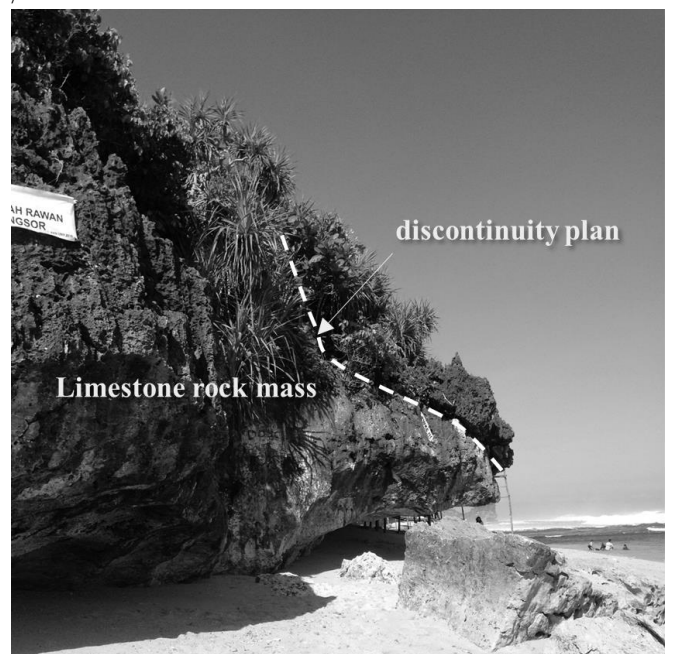
The objective of the research is the South Coast of Gunung Kidul, focused on rock cliffs with high level of susceptibility, as on the Sadranan Beach, in order to obtain the rock type verification. The study location and the rock failure case are shown in Figure 2, and Figure 3, respectively.

Figure 3. Potential slope failure in Sadranan Beach

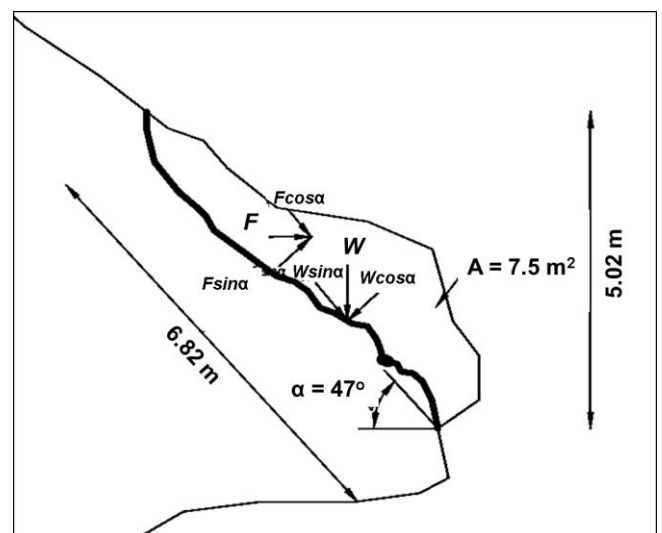
where  $W$  is the weight of the sliding block,  $F$  is the dynamic load assumed as pseudo-static force and  $\alpha$  is the average inclination of the sliding block. The variables are indicated in Figure 4. The Barton criterion safety factor analysis will limitedly consider the block as the sliding material, while the whole structure of the hanging rock will be numerically analyzed by using Plaxis.

Figure 4. Forces acting on sliding block in the Barton criterion safety factor analysis

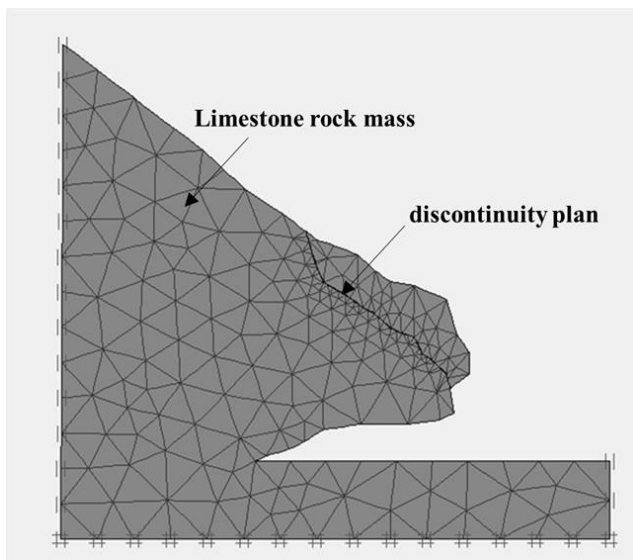
Figure 5. Elements configuration in Plaxis analysis

carbonate rock. Both materials have contrast shear strength, whereas infilling material has only 50% strength that of carbonate rock. It suggested that the presence of infilling in discontinuity plan could highly affect the stability the rock slope. In the numerical analysis using Plaxis, the infilling material was modeled as soil thin interface element in the discontinuity plan (Figure 5).

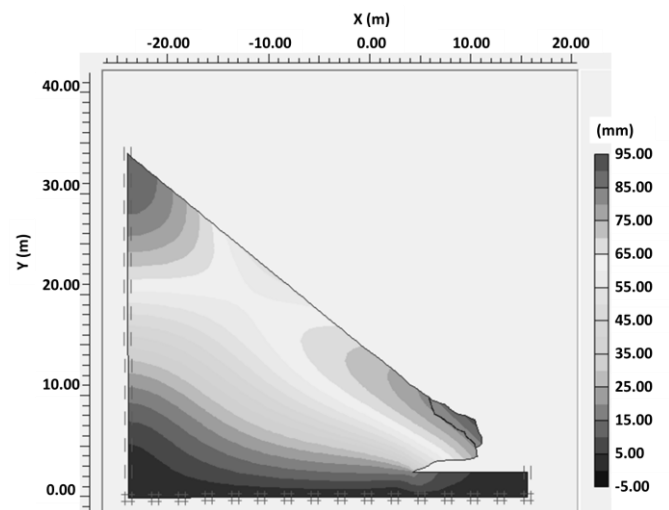
Results from the numerical analysis using finite element program, Plaxis, suggested that the rock slope are safe during static condition. However, the generation of dynamic load into the model makes the slope becomes unstable. Figure 6 shows the displacement in the rock slope model on unfilled condition. The mean stresses diagram suggested that the compression stresses concentrated at the lower part and the tension at the upper part (Figure 7).The figure suggested that potential failure is originating from the intact rock body instead of the plane of discontinuities. The notch structure of the slope fully controls the stress strain behavior. Therefore, the mitigation action should consider the whole notch structure and the rock joint as well.

Figure 6. Displacement in the rock slope model on unfilled condition for dynamic condition

The field investigation and laboratory test suggest that the presence of infilling in discontinuity plan could highly affect the stability the rock slope. However, the finite element model suggested that potential failure is originating from the intact rock body instead of the plane of discontinuities. Therefore, the mitigation action should consider the whole notch structure and the rock joint as well, especially on seismic condition which could dramatically reduce the stability of the slope.

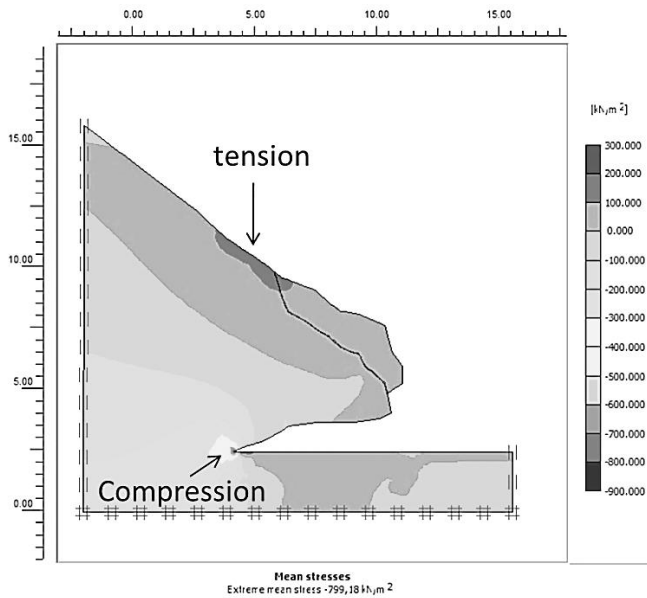
Figure 7. Mean stresses diagram

The stress distribution from Plaxis analysis shows that the potential cracking of the upper part of the hanging rock structure which indicated by concentrated tension stress, while there is no indication of shear stress mobilization in the discontinuity plan.
