Snake Line Performance Applying Single Pixel X-Band MP Radar Data (Case of Mt. Merapi Area, Indonesia)

Ani Hairani^{1,2*}, Adam Pamudji Rahardjo², Djoko Legono², Istiarto²

KEYWORDS XMP Radar; Snake line; ARR; Disaster risk mitigation

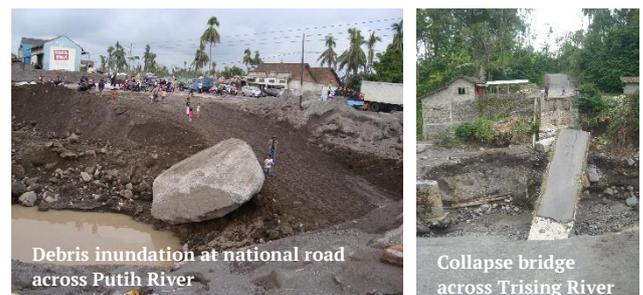
Figure 1. Damages due to debris flow disasters in the aftermath of 2010 Mt. Merapi eruption

Heavy rainfall at the beginning of the rainy season after the 2010 eruption has caused debris flow disasters in major rivers in the area (Figure 1). A world cultural heritage, the Prambanan Temple, was threatened by serious damage of debris flow occurrences during the rainy season in November 2010 to March 2011 (Figure 2).

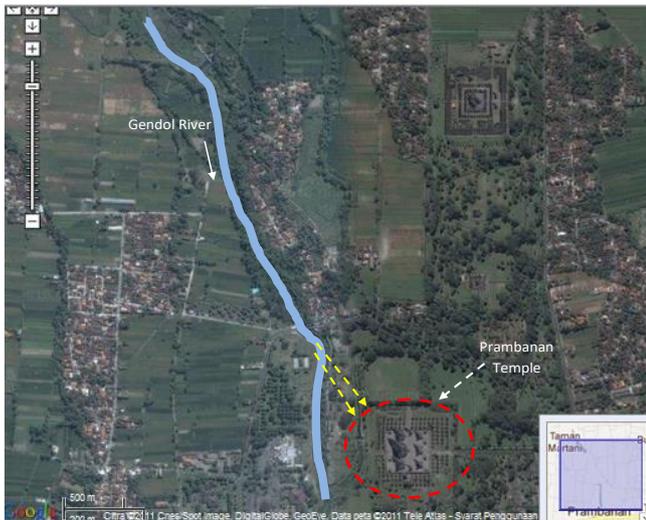
Figure 2. Potential threat of debris flow on the world cultural heritage of Prambanan Temple

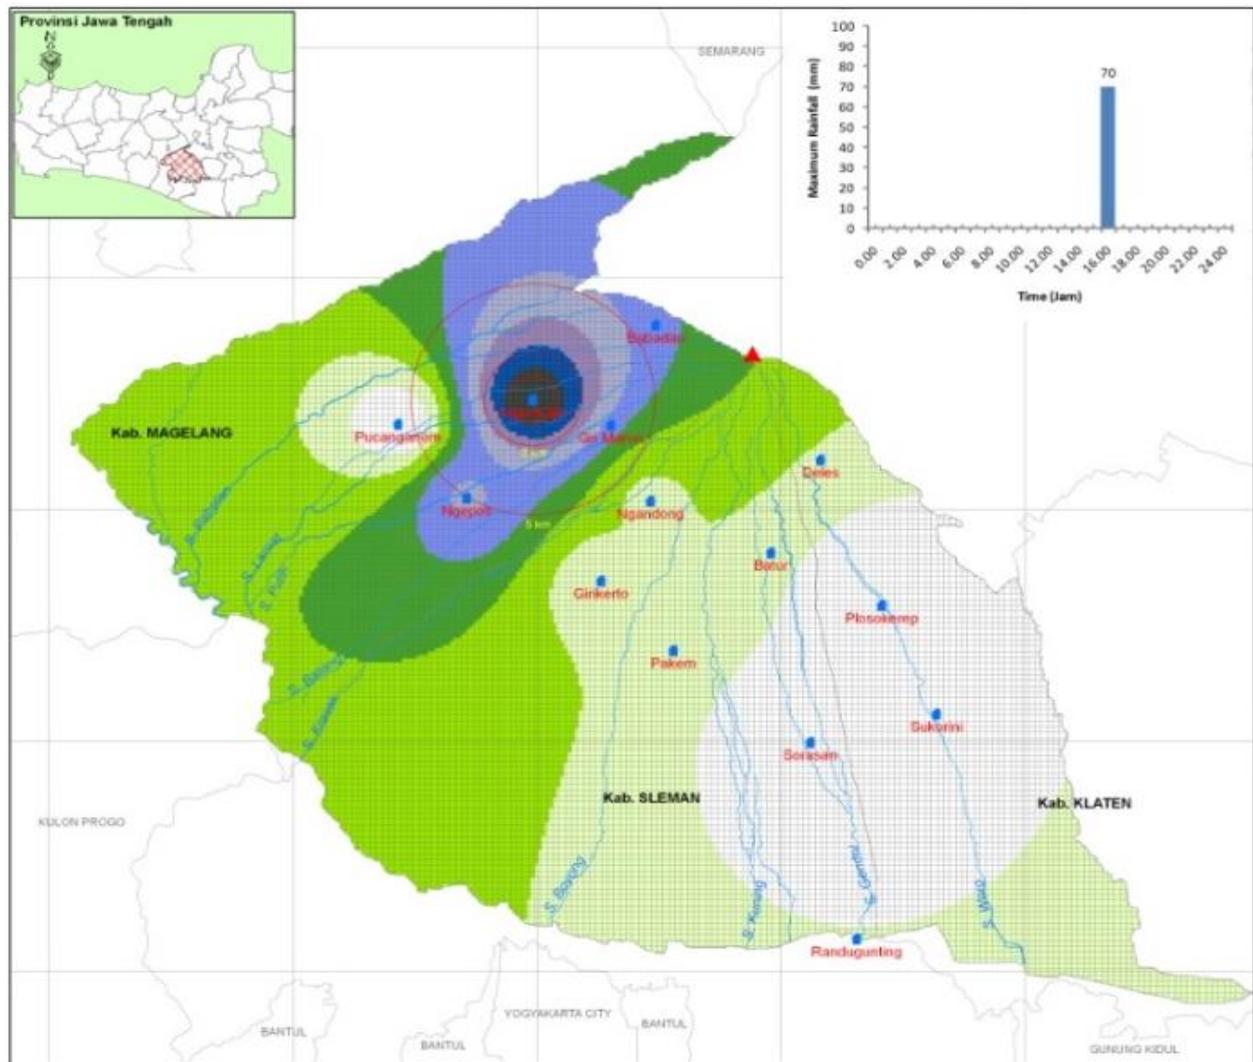
Figure 3. Distribution of maximum hourly rainfall intensity at Mt. Merapi area (Prayuda, 2012).

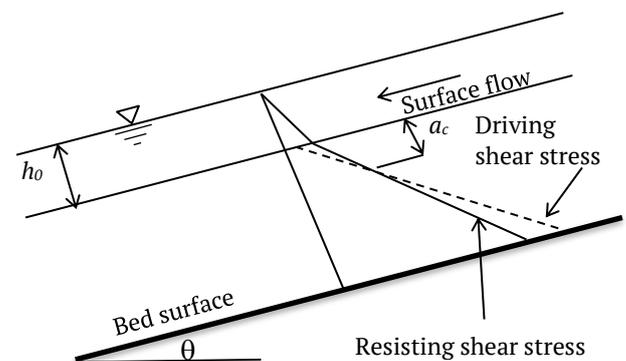
Figure 4. Stress distribution on a sediment layer under the effect of surface flow (Takahashi, 1991)

Equation (1) assumes that the surface flow does not appear or it coincides with the bed layer (Figure 4). The critical index of Takahashi derived from Equation (1) by considering surface flow h_0 is shown in Equation (2).

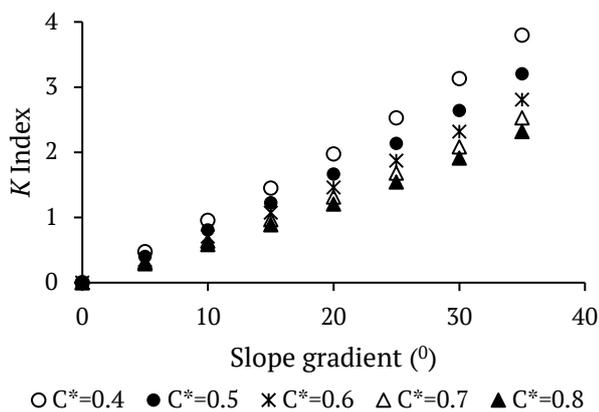
Figure 5. Correlation between critical index of Takahashi, slope gradient, and sediment concentration (Wardoyo, 2013)

One of human activities at Mt. Merapi area is sand mining activity. Such activity has become a dominant factor affecting the instability of the sediment source. For some extent, the sand mining activity has made the deposit unstable because the sediment concentration C^* reduces considerably. The sensitivity analysis of the instability of the sediment source based on Equation (2) showed that the declining of the sediment concentration C^* from 0.7 to 0.5 has caused 15% increase in the risk of debris flow occurrence. Figure 5 explains sensitivity analysis describing the correlation between the critical index of Takahashi, slope gradient, and sediment concentration.

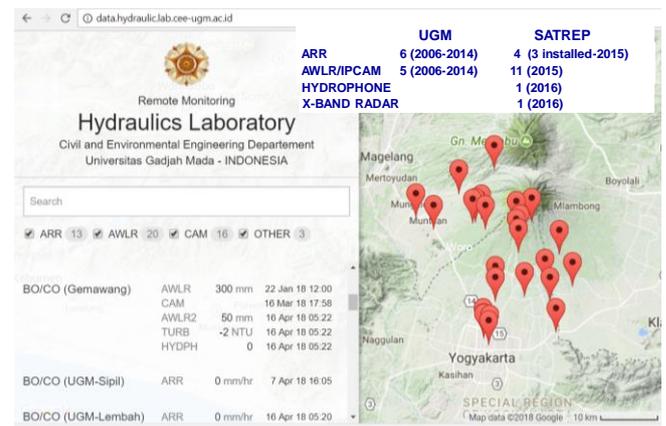
Figure 6. Hydrology and hydraulics monitoring system (Civil and Environmental Engineering Department, 2019)

Merapi eruption in 2006, the Hydraulics Laboratory, Universitas Gadjah Mada, has also been developing hydrology and hydraulics monitoring system at Mt. Merapi area. Through the five years (2015-2019) of research collaboration under the SATREPS (Science and Technology Research Partnership for Sustainable Development), the aforesaid monitoring system has been expanded to cover larger area. The hydrology and hydraulics monitoring system currently being maintained is summarized as follows (see Figure 6.).

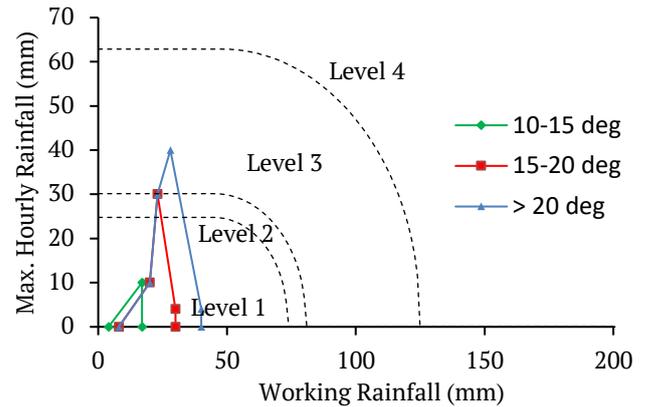
Figure 7. Warning criteria of debris flow occurrence applied in Mt. Merapi (Balai Sabo, 2019).

Balai Sabo has developed critical line as warning criteria for debris flow according to two rainfall indices, namely hourly rainfall and working rainfall. The critical lines as can be seen in Figure 7 were drawn objectively using Radial Basis Function Network and selected by the concept of capture rate percentage (Putra, et al., 2018). Each critical line indicates debris flow probability level, i.e. Level 1 when there is no risk of flood, Level 2 if there is a risk of flood but not large, Level 3 when there is a high risk of flood evidenced by many flood occurrences recorded in Level 3 in the past, and Level 4 for an extremely high risk of flood (Balai Sabo, 2019).

The warning criteria are also divided into three categories of location based on the slope, i.e. in the range of 10° - 15° , 15° - 20° and steeper than 20° . From this critical line, debris flow occurrence can be predicted by real-time rainfall monitoring.

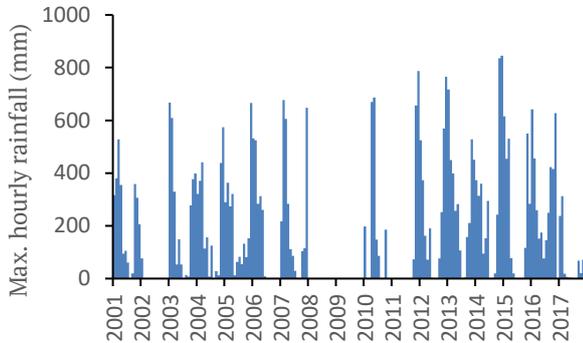
Figure 8. Maximum hourly rainfall in Babadan station (2001-2017)

Figure 8 shows maximum hourly rainfall in Babadan station within 17 years. The figure shows an increasing trend of maximum hourly rainfall. On 28 and 29 November 2017, Cempaka and Dahlia storms attacked Indonesia and caused heavy rainfall. These storms brought high flow at Lower Opak River that caused two bridges, i.e. the Nambangan Bridge and Soka Bridge, collapse. Figure 9 shows the bridges' conditions before and after the collapse.

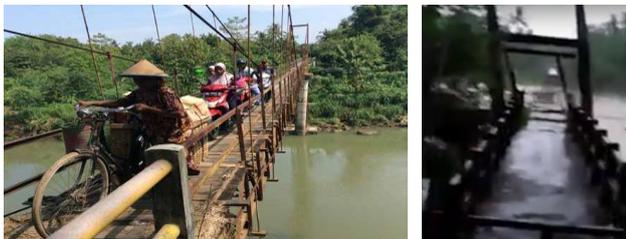
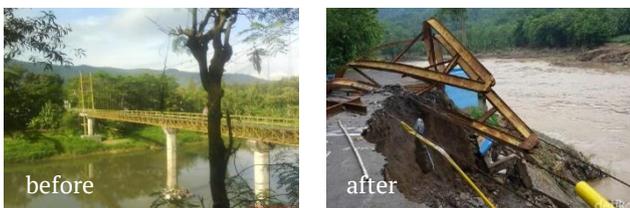
a). Nambangan Bridge (before and after the collapse)

b). Soka Bridge (before and after the collapse)

Figure 9. Damages to Nambangan and Soka bridges due to Cempaka and Dahlia storms

It was reported that the bridges' collapse took place on 28 December 2017, when the river water level reached its highest elevation. The rainfall intensities during 27 to 30 November 2017 recorded at the ARR of BO/CO Station were as follows :

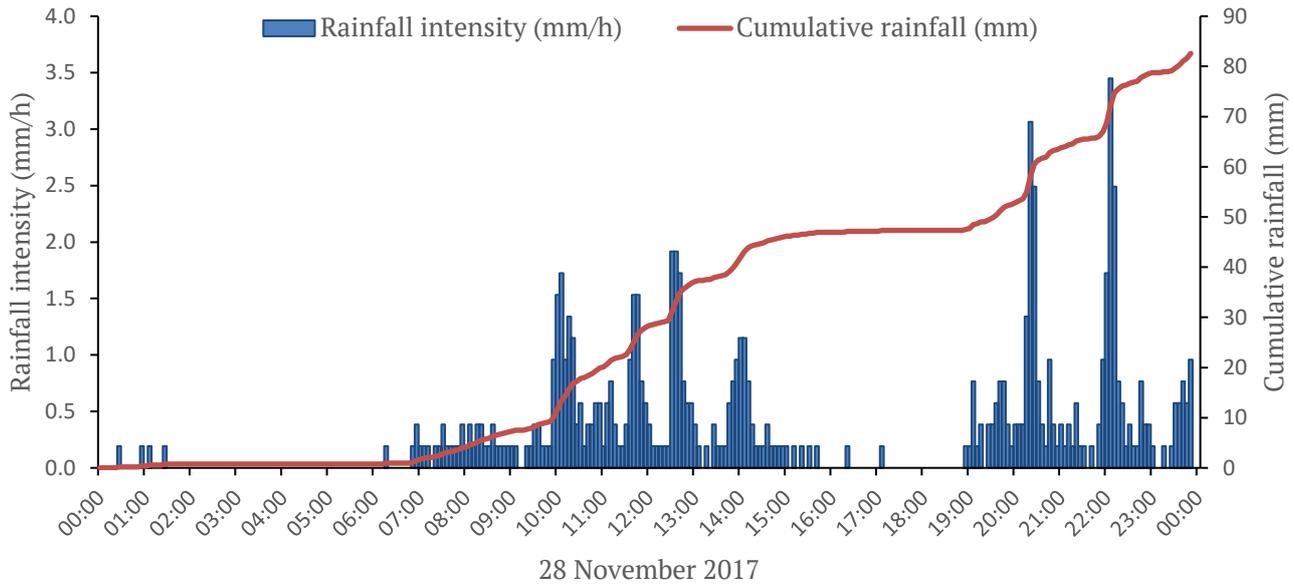
Figure 10. Five-minutes rainfall intensity during 28 November 2017 at ARR-BO/CO Station

The short duration (5 minutes) rainfall on 28 November 2017 is shown in Figure 10.

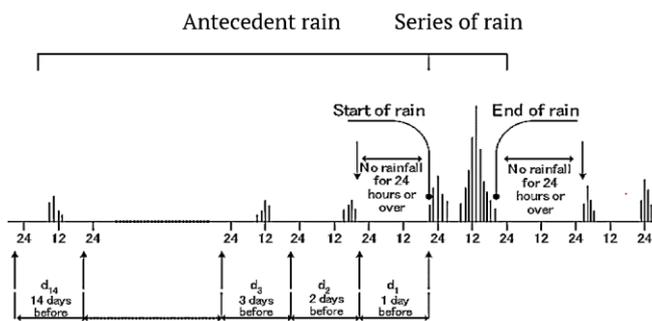
Figure 11. Rain series and antecedent rainfall concept (Ministry of Land, Infrastructure, and Transport (MLIT), 2004).

considered effective for debris flows because the tank model used for this derivation was found to be effective to predict debris flow occurrence (Ministry of Land, Infrastructure, and Transport (MLIT), 2004). Two rainfall indices were introduced, namely hourly rainfall and working rainfall. Hourly rainfall is a cumulative rainfall within one hour, while working rainfall is calculated using Equation (6). Working rainfall method proposed by MLIT is the accumulation of antecedent rainfall and cumulative rainfall in the series of rain. A series of rain is defined as a continuous rainfall separated by 24 hours or over of no rainfall.

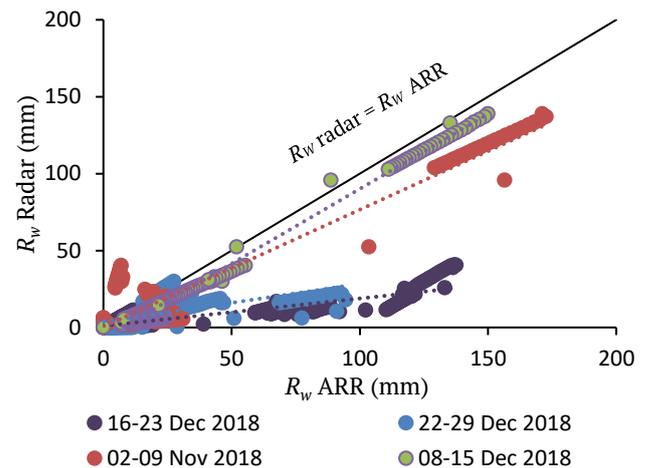
Figure 12. Comparison of working rainfall derived from XMP radar and ARR data

Degree of discrepancy between working rainfall developed by ARR and X-Band MP Radar varies for each case. However, all cases of rainfall are found below the line of $R_w \text{ radar} = R_w \text{ ARR}$. It indicates that working rainfall derived from radar is lower than that from ARR. The smallest discrepancy is shown in rainfall event from 8 to 15 December 2018. Implementation of the radar rainfall data on the delineation of snake line in another extreme condition, which was recorded on 8-9 November 2018, is shown in Figure 13(d). Radar rainfall intensity in a 60-minute interval was chosen at the location of ARR PU-D2 station. Figure 13(a) to Figure 13(c) show the distribution of rainfall intensity gained from radar monitoring at, respectively, 14:58, 15:58, and 16:58, on 9 November 2018.

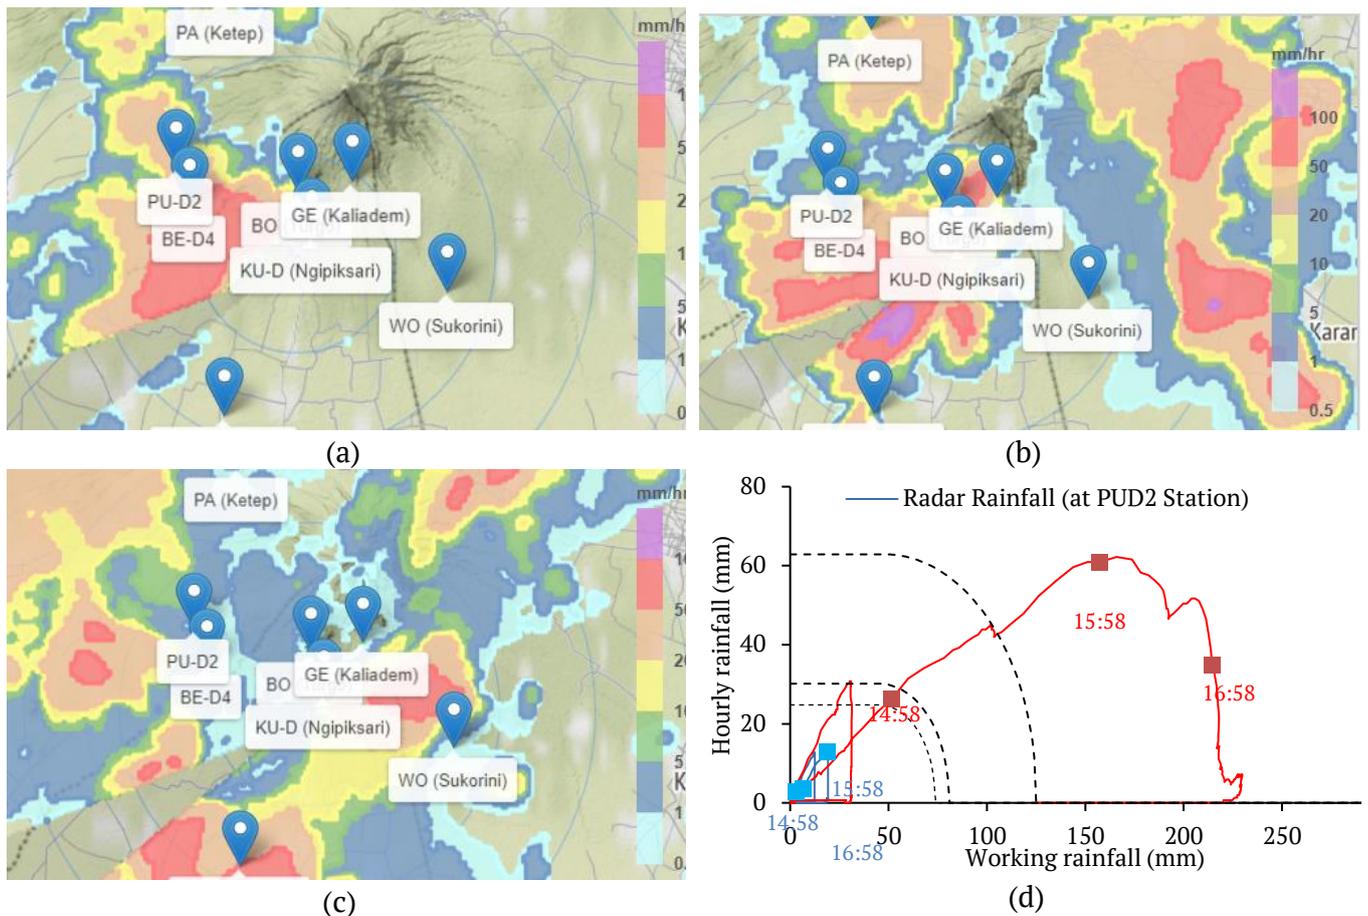
Figure 13. (a) Rainfall intensity gathered from the XMP Radar at 14:58, 9 November 2018; (b) Rainfall intensity gathered from the XMP Radar at 15:58, 9 November 2018; (c) Rainfall intensity gathered from the XMP Radar at 16:58, 9 November 2018; (d) Comparison of snake line between ARR data and radar data at PU-D2.

Figure 13(d) shows snake lines based on ground rainfall data (ARR) and X-Band MP Radar rainfall data at the same location, namely PU-D2, with 60-minute interval. Figure 13 clearly shows significant difference between ARR and X-Band MP Radar based snake lines. Data from ARR yields much higher rainfall amount than those of radar. Snake line based on XMP Radar data was generally two levels below that based on ARR data. This case suggests that further study is required on the correlation between radar and ground station rainfall data.
