3D Back Analysis of Karyamekar Landslide, West Java, Indonesia: Effects of Tension Crack and Rainfall on Peak and Residual Soil Shear Strength

Aisya Galuh Laksita, Fikri Faris*, Ahmad Rifa'i

Department of Civil and Environmental Engineering, Universitas Gadjah Mada, Yogyakarta, INDONESIA
Jalan Grafika No 2 Yogyakarta

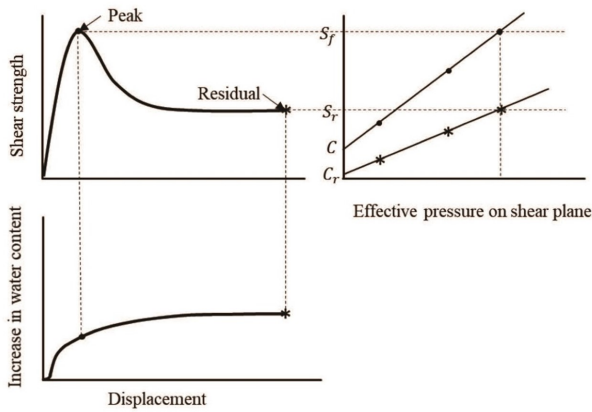
Figure 1 Concept of soil shear strength (Fang et al., 2020)

in Figure 1, where S_f is peak strength, S_r is residual strength, C is cohesion at peak strength, and C_r is cohesion at residual strength (Fang et al., 2020). It is important to state that peak shear strength is used only in cases of first-time slope failure (Kondalumahanthy, 2013). Meanwhile, residual shear strength is normally applied in stability analysis of ancient landslides, evaluation of reactivation potential, and understanding of progressive failure mechanisms (Chen and Liu, 2014).

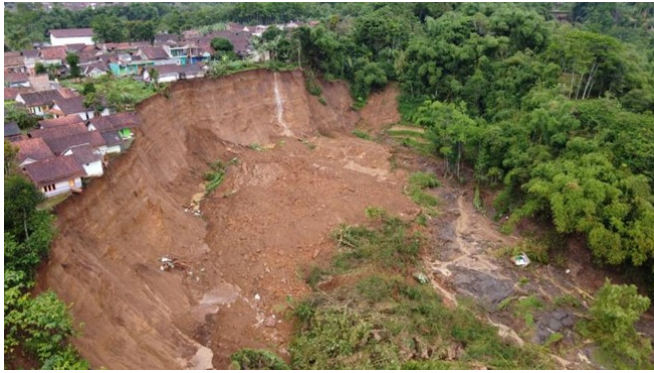
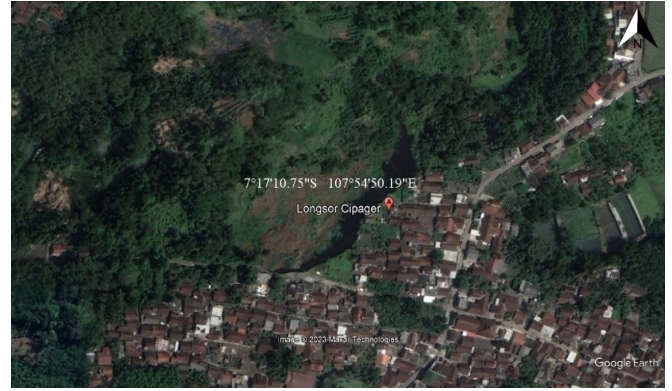
Figure 2 Aerial photograph

(a) Landslide area (Prihammada and Putra, 2021)

(b) Landslide area (Google Earth, 2023)

spanned approximately 300 m long with a depth of 20 m (Al Ghifari, 2021), leading to a steep slope as presented in Figure 2. Therefore, this study aimed to conduct a 3D back analysis to determine soil shear strength with due consideration for the effect of tension crack and rainfall on slope stability. The results were expected to be subsequently used to analyze the potential for further landslide. The field conditions considered include the presence of tension crack in slope and heavy rainfall before landslide occurred. This showed that the factors of tension crack, water table, and rainfall were included in back analysis.

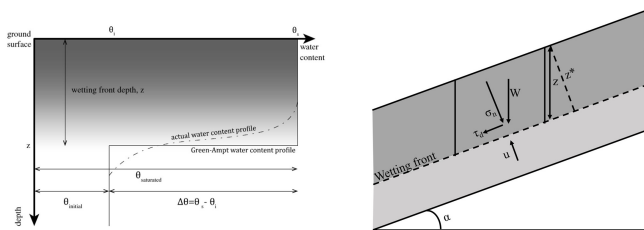
Figure 3 (a) Green-Ampt piston-type water content profile compared to the actual water content profile, where z is wetting depth, and $\theta_{initial}$ and $\theta_{saturated}$ are the initial moisture and saturated conditions, respectively, and (b) infinite slope model (Dolojan et al., 2021)

Infiltration analysis was conducted using Green-Ampt method in order to model the effect of rainfall on slope. The method proposed an analytical simplified solution for infiltration of one-dimensional vertical rainfall with the occurrence of ponding or excess water on soil surface. Under ponding, infiltration was assumed through homogeneous soil with a uniform initial moisture distribution. The model also assumed a uniformly increasing wetting front (piston type), with constant soil matric suction, separating the maximum saturated soil from the unsaturated soil at initial moisture as presented in Figure 3a (Dolojan et al., 2021).

Where, z^* represents wetting front, normal to surface slope as presented in Figure 3b. Wetting front measured vertically from surface can be calculated using Equation 6.

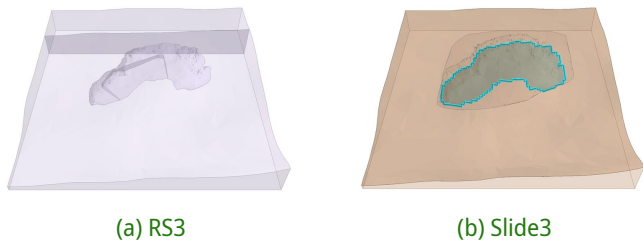
Figure 4 Model

currence of landslide. The dimensions of tension crack, including length and width, were parameterized based on aerial photographs provided by PVMBG. The depth of tension crack was simulated until it intersected with the slip surface. In RS3 software, a novel plane was generated to accommodate a pressure head mirroring the depth of tension crack in order to facilitate the integration of realistic conditions into the model. Slope geometry in RS3 and Slide3 software are presented in the following Figure 4. Moreover, soil parameters applied to the model are listed in Table 1.

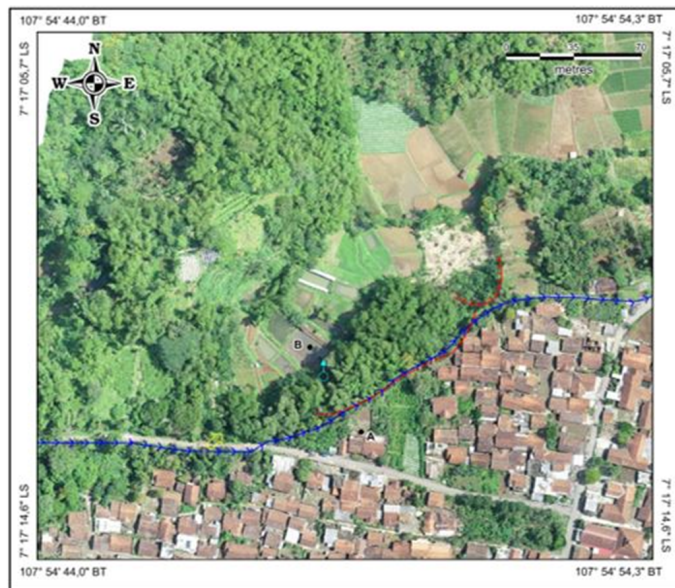
Situation Map of Creeping in Cipager Karyamekar, Cilawu, Garut, West Java

Figure 5 Creeping situation map of Cipager, Karyamekar (Kementrian ESDM Badan Geologi PVMBG, 2020)

had a quite complex effect as shown by the need to provide additional load to the water pressure on slope. The influence was also observed from the extension of tension crack near the drainage path. This condition led to the assumption that tension crack was filled with water. The fully saturated tension crack was modeled as a pressure head of 7 m based on its depth up to the sliding plane. Moreover, the area of tension crack was adjusted to PVMBG ground movement report as shown in Figure 5.

2. Drainage has a complex role in contributing additional water stress to slope. Therefore, tension crack was assumed in this study to be filled with water because it was adjacent to the area of the damaged drainage as presented in Figure 5. This assumption used was the worst-case scenario due to the water pressure in tension crack.

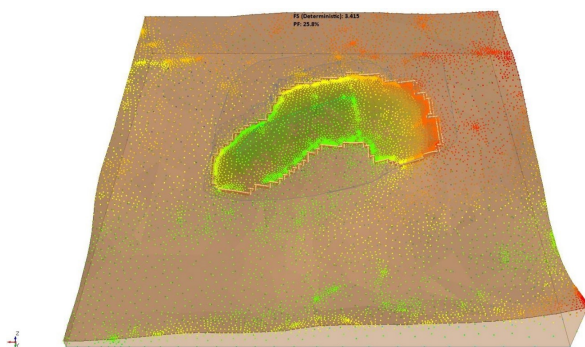
Figure 6 Pore water pressure analysis result

The results obtained from the hydraulic computations used to determine pore water pressure are presented in the following Figure 6. The results were later exported as pore water pressure grid for slope stability analysis using the limit equilibrium method in Rocscience Slide3 software.

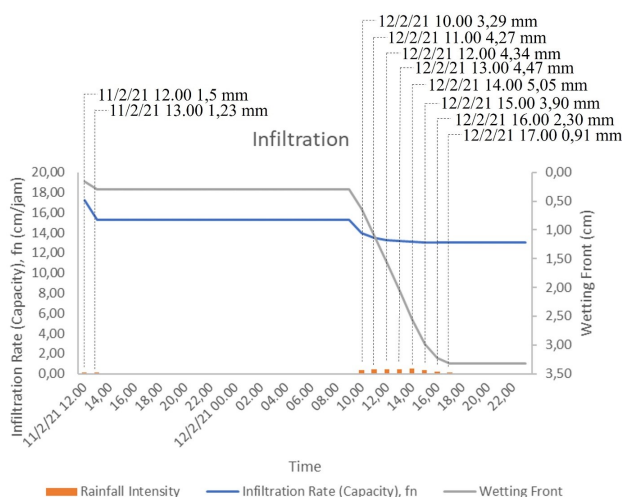
Figure 7 Green-Ampt infiltration analysis result chart

The effect of rainfall was considered as infiltration causing the development of a saturated soil layer in slope stability analysis. The depth of the saturated soil layer was calculated using Green-Ampt infiltration in Equations 2 to 6 based on the parameters listed in Tables 1 and 2. Infiltration was analyzed three days before the event through wetting depth analysis conducted using Green-Ampt infiltration method. The results presented in Figure 7 showed that wetting depth was approximately 3 cm.

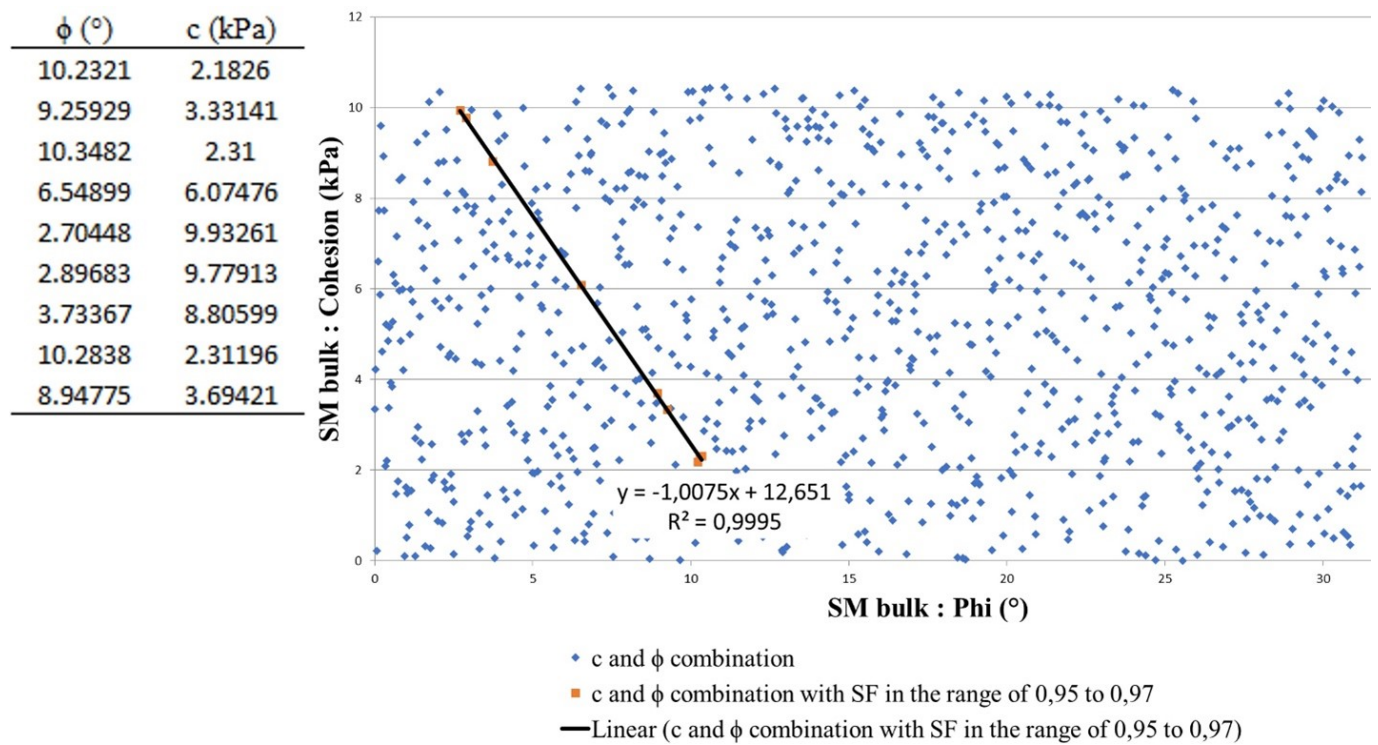
Figure 8 c- ϕ residual combination

Figure 8 shows the combination where one of the parameters, c or Φ , is more dominant. The single value used as residual shear strength was selected through the application of two combinations in the table to the initial slope in the model before landslide as well as the combination with the highest Φ value and the one with the highest c value. The legend was set to ensure the uppermost color contour, which was dark blue, showed safety factor of 0.95 while the other colors had a lesser value. Figure 10 shows the difference in landslide area expected when a combination of shear strength with dominant Φ value or a combination with dominant c value was used. The modeled landslide area represented using other colors apart from dark blue is observed to be closer to the field situation shown by the shaded part when using the dominant Φ combination compared to the dominant c value. This showed that residual shear strength from the combination of Φ at 10.35° and c at 2.31 kPa was used.

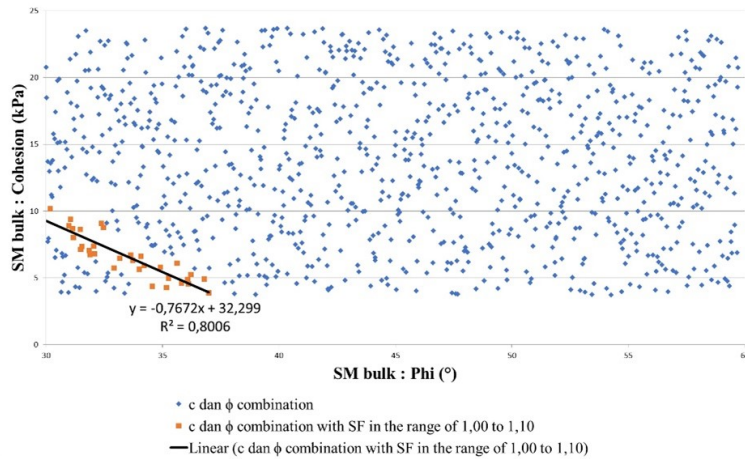
Figure 9 c-φ peak combination

model from the moment after landslide up to when the safety factor ≥ 1.00 was obtained. The results presented in Figure 9 showed some points with different colors, implying the combinations of c and Φ of soil had the same safety factor values of 1.00 to 1.10. Back analysis was also applied to validate peak strength values produced through the laboratory test (Thiel, 2001). This was achieved using the value that was closest to the 31.18° in the laboratory test with cohesion value of 8.01 kPa. Moreover, peak shear strength value was also validated through slope stability analysis using the previous model, and slope was found to be safe against landslide with a minimum safety factor of 1.08, as shown in Figure 11. The result showed there was no landslide on the modeled slope in line with the field conditions. Therefore, peak shear strength modeled was considered relevant for slope shear strength in further landslide potential analysis.

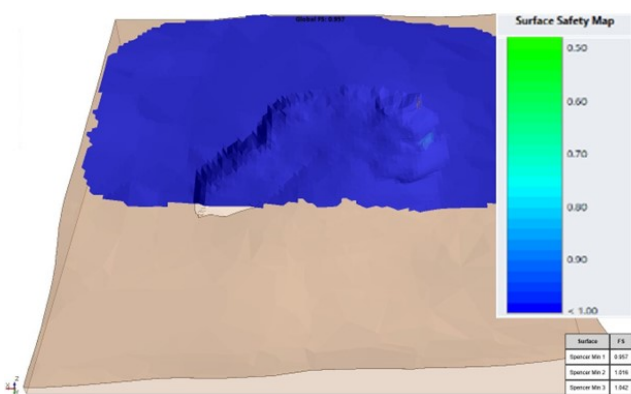
Figure 11 Landslides did not occur in the model to which the peak shear strength of back analysis was applied

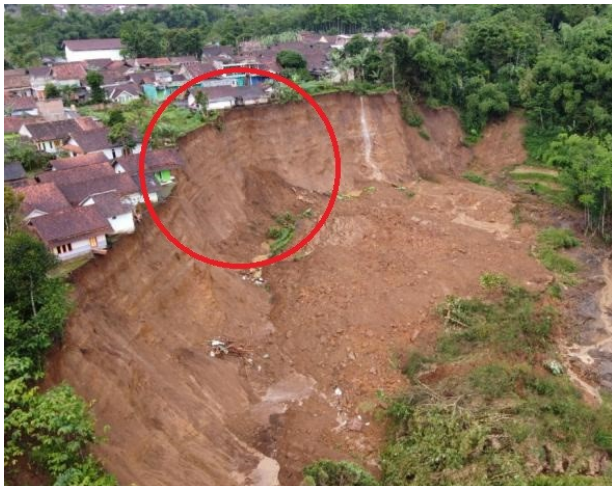
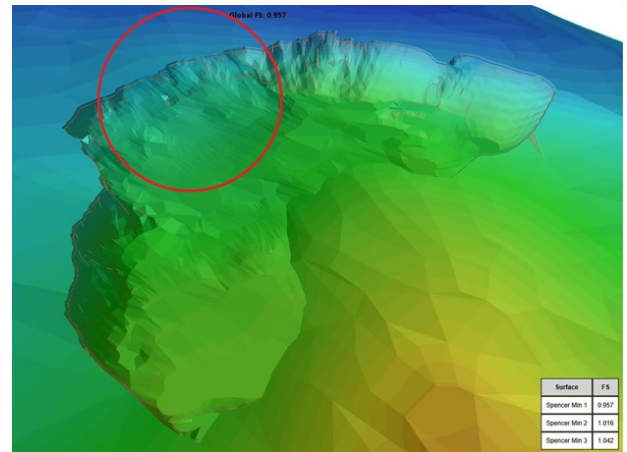
(a) Aerial photos

(b) Model geometry

Figure 12 Comparison between the south slope

3. Landslide geometry modeled was different from the aerial photographs of the area. This is observed from Figure 12 where slope appears steeper than the contour from the DEM drone in the aerial photo. These differences

are possibly due to the variations in the accuracy of DEMs because DEMNAS obtained from the BIG web has a resolution of 8 m while the drone DEM has a resolution of 0.3 m which can reduce the accuracy level of the model. The marked section shows that slope on the south side is steep but the drone DEM shows it is flatter. Meanwhile, steep slopes have the ability to significantly influence collapse more than flat slopes.
