# Rock Mass Characterization for Assessment of Safe Cut Slope and Rock Bearing Capacity at Gondang Dam Site, Karanganyar, Indonesia

ABSTRACT. This paper presents results of surface rock mass characterization for assessment of safe cut slopes and allowable bearing capacity of foundation rocks at the construction area of Gondang Dam. The rock mass characterization involved determination of intact rock engineering properties and rock mass quality based on the Geological Strength Index. The rock mass characterization results showed that the research area consisted of moderately to highly weathered and very weak to weak andesite breccia and andesite tuff breccia. The andesite breccia had very poor to fair rock mass quality, while the andesite tuff breccia had poor to fair rock mass quality. The research area was divided into three zones of safe cut slope and allowable bearing capacity. Landslides occurred at natural slopes having poor to very poor rock mass quality and inclinations greater than the determined safe cut slopes. The foundation rock of the embankment dam had fair rock mass quality and 135–280 T/m² allowable bearing capacity.

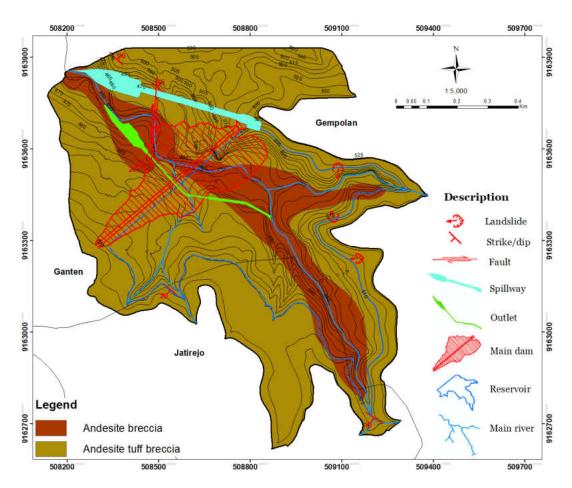
Results of the site investigation indicated that the research area consisted of two rock units, namely andesite breccia and andesite tuffbreccia (Figure 2). Referring to the regional geological map produced by Sampurno and Samodra (1997), the two rock units were likely member of Lawu Volcanic (Qvl). Figure 3 and 4 show typical outcrops of the two rock units. The andesite brecciatypically consisted of 50 % of 2 cm to 1 m-sized andesite fragments, 45 % of medium to coarse sand-sized matrix, and 5 % of tuff. The andesite tuff breccia typically consisted of 30 % of 1 to 20 cm-sized andesite fragments, 30 % of fine sand-sized matrix, and 40 % of tuff.

Figure 2: Spatial distribution of rock units in the research area.
