NON SURGICAL LATROGENIC PERFORATION REPAIR USING MINERAL TRIOXIDE AGGREGATE AND DIRECT RESTORATION WITH FIBER POST ON CENTRAL MAXILLARY INCISOR

Hendargo Agung Pribadi dan Yulita Kristanti

Department of Conservative Dentistry
Faculty of Dentistry- Universitas Gadjah Mada
Email: jodarjo@gmail.com

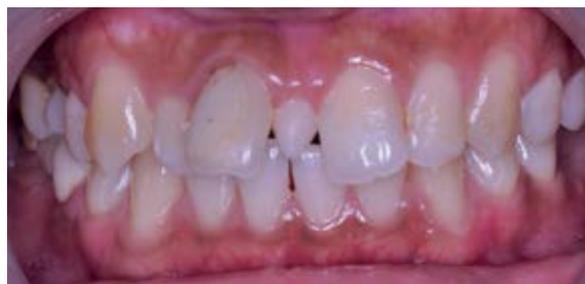
Figure 1.
Clinical appearance of the anterior teeth before the treatment. Maxillary right central incisor looks distolabiotorsion

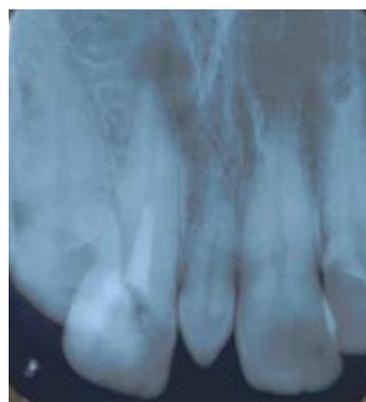
Figure 2.
New radiograph diagnosis was taken. There is a radiolucency at periapical of maxillary right central incisor. The previous operator did not read the radiograph carefully.

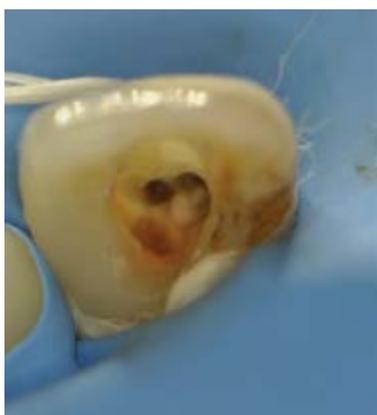
Figure 3.

In this case, the maxillary central incisor be through distolabiotorsion which is needed a good imagination of 3D tooth anatomically. In this case, a lack of understanding about imagination anatomy the tooth could be a reason iatrogenic perforation. After removing temporary cement, there was a cavity with dark spot which is tunnel-like. To detect the perforation, K-file was used to project the tunnel through mucosa gingival labial deliberately.

Clinical appearance from incisal side. There were two spot of iatrogenic perforation (arrow)

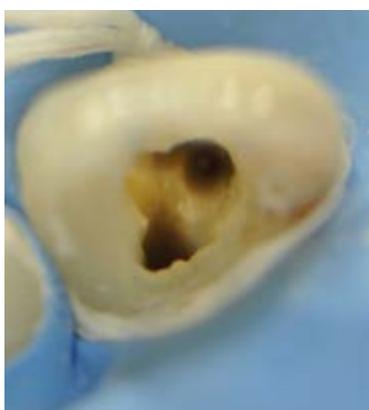
Figure 4.

Clinical appearance the tooth after locating the orifices.

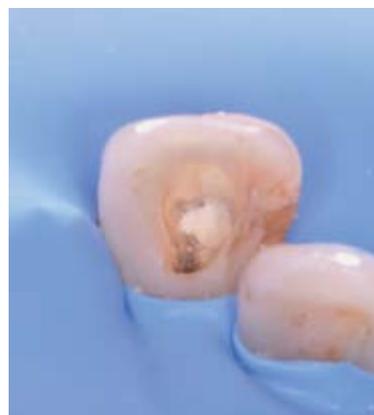
Figure 5.

Clinical appearance the perforation was sealed by MTA

MTA or mineral trioxide aggregate introduced by Torabinejad 20 years ago, consists of fine hydrophilic particles of tricalcium silicate, tricalcium aluminate, tricalcium oxide, silicate oxide, calcium sulphate dehydrate, tetracalcium aluminoferrite, and small amounts of mineral oxides (bismuthoxide). MTA is derived from Portland Cement with a slight difference in composition (Wen his wang). The major component (tricalcium silicate, tricalcium aluminate, etc) are responsible for the setting and biologic properties, and bismuth is only for radiopaque property. MTA can stimulates cementoblasts to produce matrix for cementum formation and biocompatible with periradicular tissue. After locating orifice and root canal, MTA was prepared to seal the perforation and isolating the root canal. MTA was mixed with the ratio p:l = 3:1, then it was applied using hand plugger. MTA was condensed using small head hand plugger intercrementally.

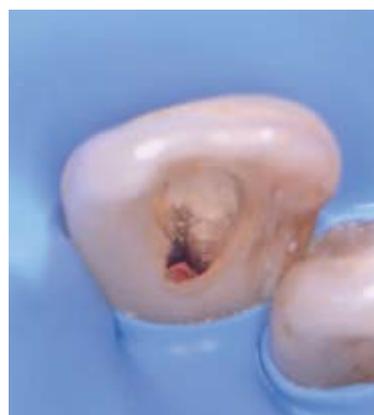
Figure 6

Clinical appearance the tooth has been done root canal treatment

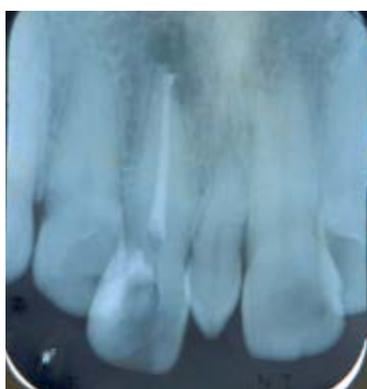
Figure 7.
Radiograph confirmation after root canal treatment and perforation sealing were done

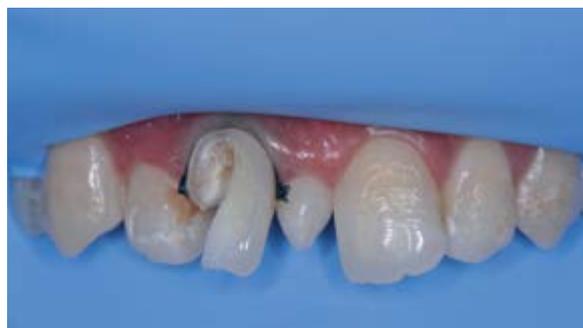
Figure 8.
The old restoration has removed while preparing for the restoration

After finishing root canal treatment, the old restoration and removing enamel unsupported dentin were done to consider the ideal restoration. Based on the rest of the hard tissue, the ideal restoration should be a crown with reinforcing using fiber post. The purpose of the restoration's plan was to seal coronal of the tooth while reinforcing the tooth and recovering the aesthetical aspect. To achieve the monoblock concept, resin based self adhesive resin cement and silanized fiber post were used. Not only for achieving monoblock concept, but also reinforcing the tooth. Fiber post was chosen because of the flexural properties closer to the dentin and aesthetical demand. However the issues of endodontically treated tooth is the tooth become brittle. Caries or trauma those causing loss structure of teeth leading to tooth more susceptible to fracture. But, some studies showed the differences is not significantly be-

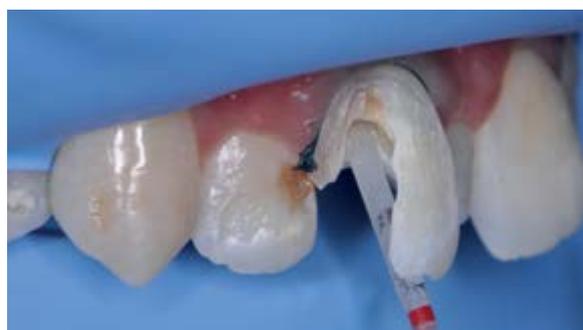
Figure 9.
Fiber post was inserted and being marked until two thirds of remaining crown.

tween endodontically treated and vital tooth. The length of post was designed minimal intervention, 8 mm from the orifice and the diameter has been confirmed with comparing the precision drill's diameter to mesio-distal of the tooth at radiograph. The minimal extension consideration was to preserve tooth's structure as much as possible. The ideal restoration for this case is crown because of the remaining structure. Due to economical reason, direct restoration using composite resin was offered to recover the function of the tooth. The function of the anterior teeth is aesthetic. In this case, new nano-hybrid filler type composite resin with spherical filler was chosen to achieve a natural color compared to adjacent teeth. The size and form of filler give the restoration look smooth and shiny.

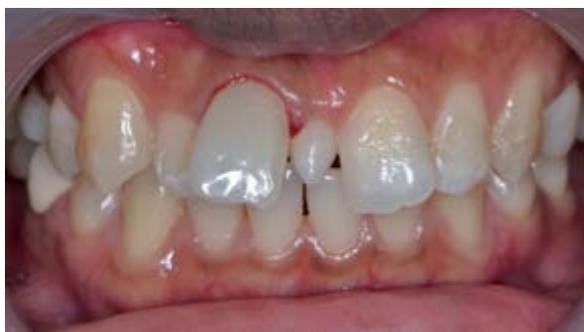
Figure 10.
The tooth was restored with composite resin directly. The restoration looks closer to the adjacent teeth

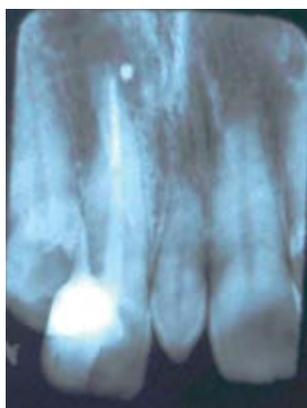
Figure 11.
Radiograph confirmation that tooth has been recovered.
